Leesylvania State Park

Erosion destabilized about 800ft of shoreline on the Potomac river and threatens walkways and picnic areas. In addition, mature trees have to be removed every year because of exposed roots and safety concerns. Active erosion and storm water runoff from upland areas contributes large amounts of fine sediments to the river.

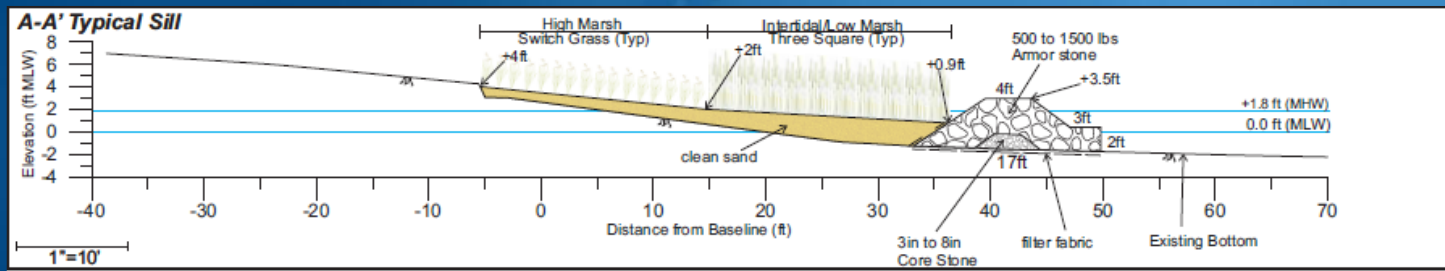
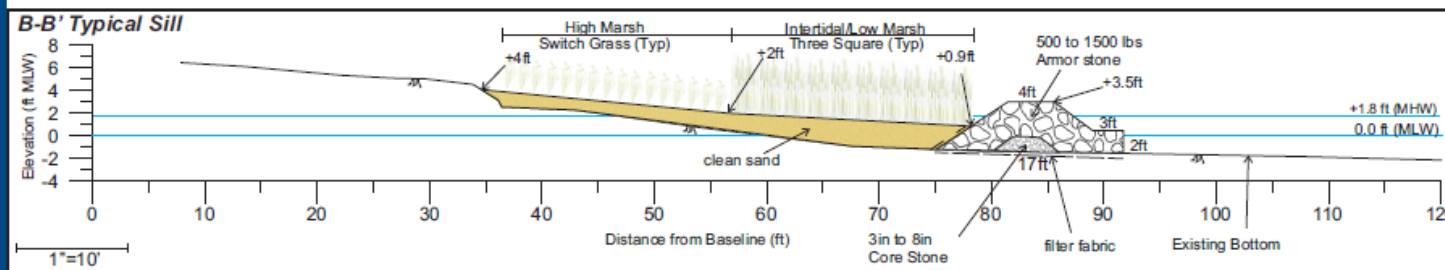
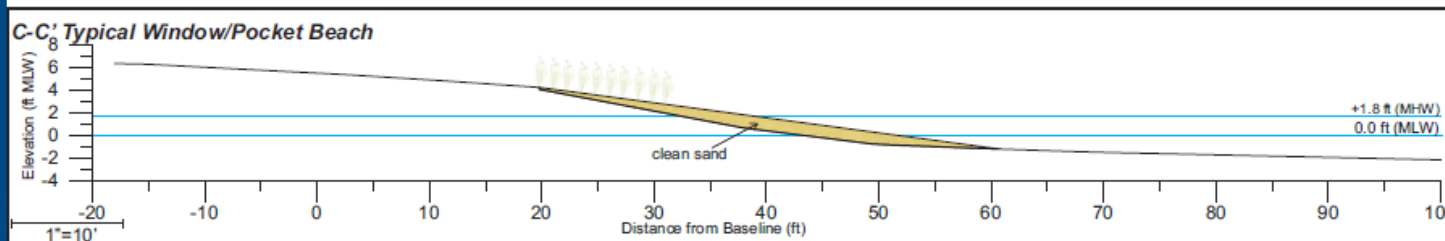
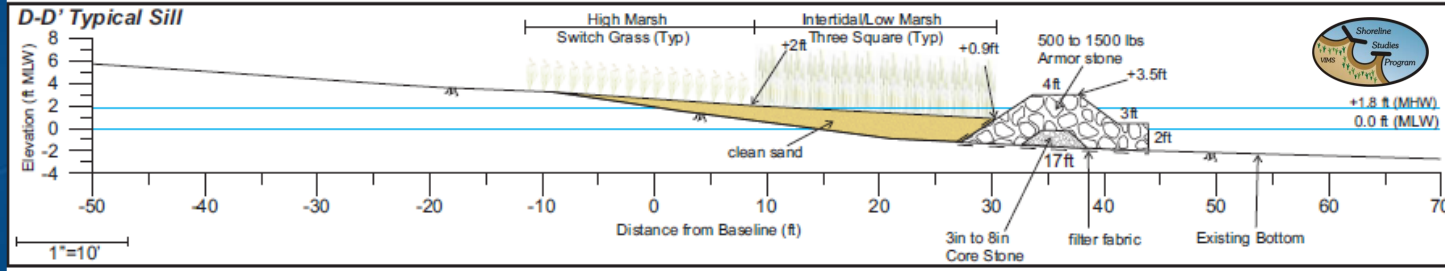
Typical Cross-sections

High energetic conditions. The sills are higher and wider than average at almost 2 feet above MHW and the crest is 4 ft wide. This site has a very low backshore so it has to be understood that flooding will still occur, but the goal is that during higher water situations, the waves will break on the structure and attenuate over the marsh protecting the upland from direct wave attack.
