Werowocomoco Shoreline Management Plan

September 2016

Prepared for
National Fish and Wildlife Foundation
And the
National Park Service

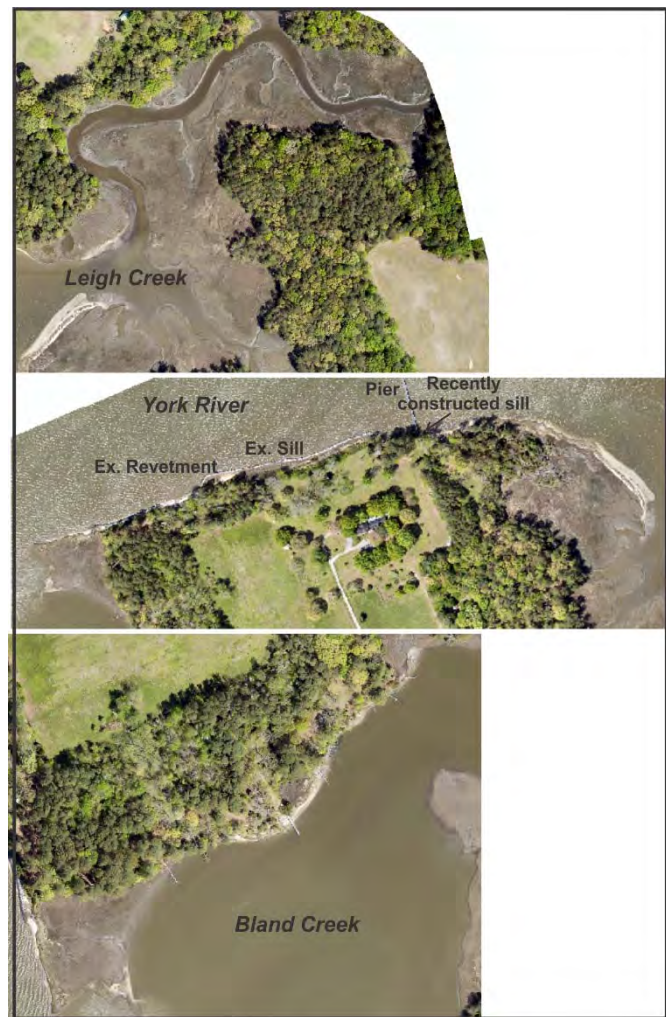
Figure 3. Rectified aerial mosaic showing the shoreline reaches at Werowocomoco.

Three reaches of shoreline exist along Werowocomoco: The shoreline along Leigh Creek, Bland Creek, and along the York River (Figure 3). The Leigh Creek reach consists entirely of marsh shoreline. The creek itself has a narrow channel, and while some channel widening has occurred since 1937, there has been relatively little change along the Leigh Creek shoreline (Figure 4).

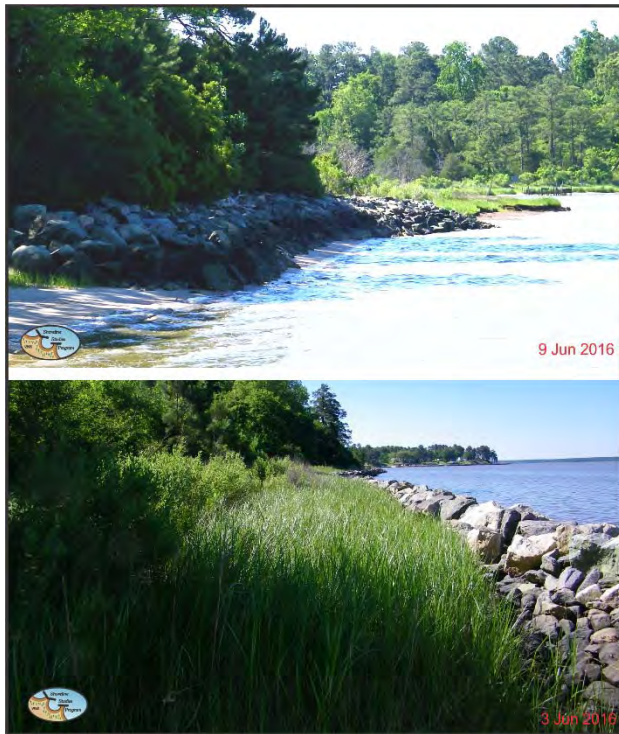
Figure 7. Top: Existing revetment along Werowocomoco. Bottom: Existing continuous high sill along the site.

Much of the York River shoreline is protected by a continuous stone sill and a stone revetment (Figure 7). The high sill protects the bank and has an established marsh habitat. The sill has reduced impacts to the upland bank which is now stable. However, the section of bank near the pier was actively eroding due to the complete loss of marsh at the site (Figure 8).

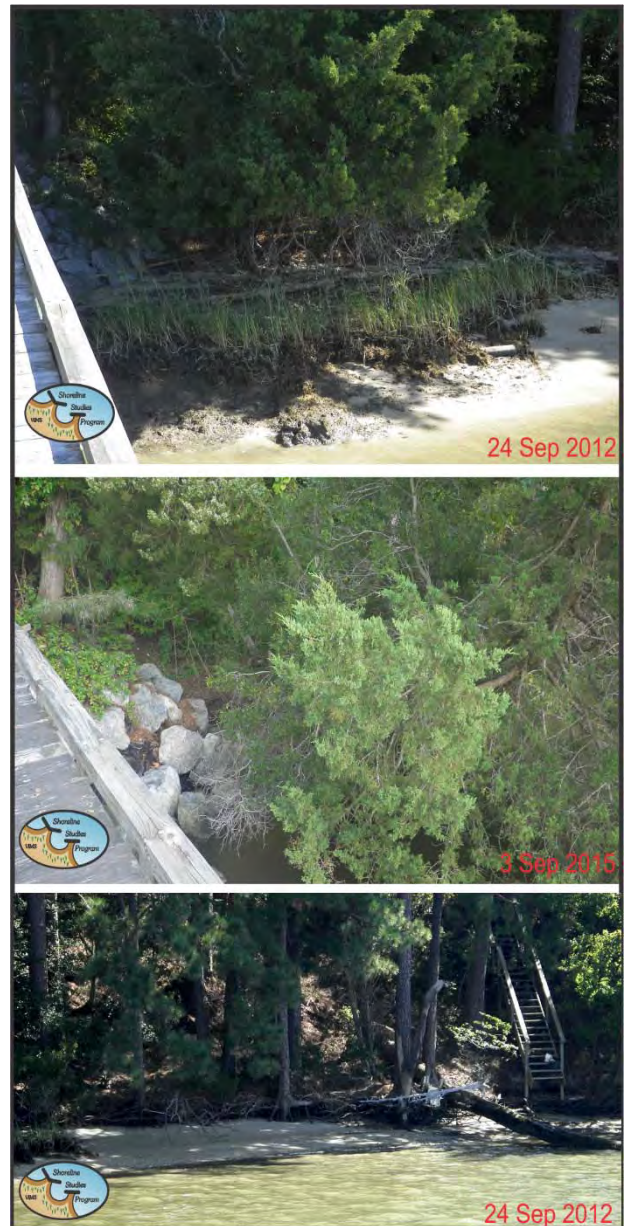
Figure 8. Marsh loss at the site. Top: In 2012, several areas of marsh still existed in front of the bank, however, it was eroding quickly. Middle: By 2015, the marsh in front of the bank was completely gone and several of the trees on the shoreline had fallen due to erosion. Bottom: Concern for archaeology in the actively eroding bank led to the placement of a gapped sill living shoreline system.

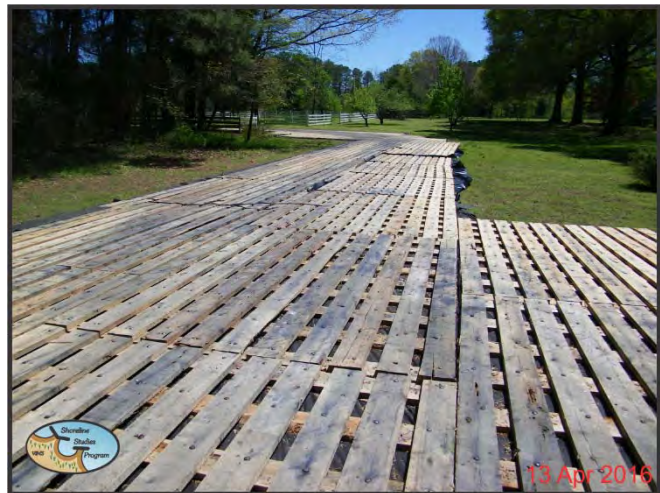
Figure 9. Logging mats and filter cloth were placed on the upland to protect potential archeology from the weight of trucks carrying materials during the project.

Bay. Construction began in March 2016 and was completed in May 2016 by Coastline Design and Construction, Inc. Two stone, gapped sills were constructed along 330 feet of shoreline (Appendix A). Planting of approximately 15,000 square feet with *Spartina alterniflora* and *Spartina patens* in May/June 2016 created marsh habitat (Appendix A). The project resulted in the reduction of 3060 lbs/ft/year of sediment, 0.7 lbs/ft/year of total phosphorus (TP), and 0.9 lbs/ft/year of total nitrogen (TN) entering the Bay through upland and marsh erosion. These numbers were calculated using site-specific information. The shore change between 1937 and 2013, as shown by the Shoreline Studies Program Shore Change Database as well as the existing bank height were used in the calculations. The TN and TP were estimated using ratios of results in Ibison *et al.* (1992). Additional site protections were enacted to protect potential archeology in the upland from potential effects of heavy truck traffic. Logging mats were placed along 1,100 feet of the property along the access route so that the weight of the trucks bringing in the rock and sand would not impact any unidentified archeology (Figure 9).

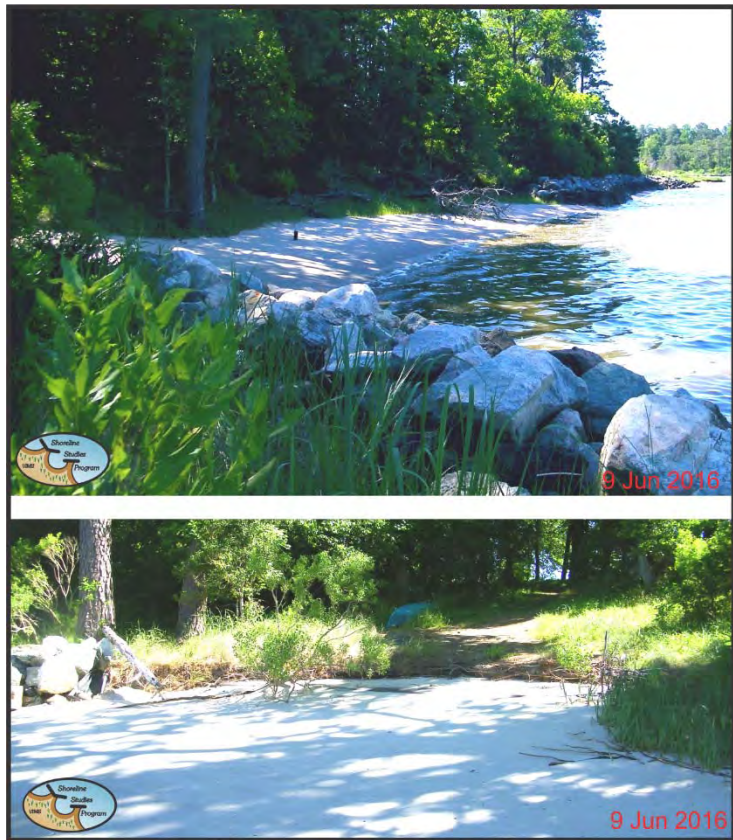
Figure 10. The sandy beach between the high continuous sill and rock revetment has a sloped bank making the area accessible.

Between the high continuous existing sill and the revetment, the shoreline consists of a sandy beach with an eroding backshore and sloped bank (Figure 10). This area of the shoreline offers excellent access to the River. In order to protect the upland bank and provide access, two spurs off the existing structures are recommended (Figure 11). These structures are 80 and 90 feet long, 15 and 18 feet wide, 4 feet high and extend at an angle from the existing structures. Sand will be placed between the structures to maximize accessibility to the water.

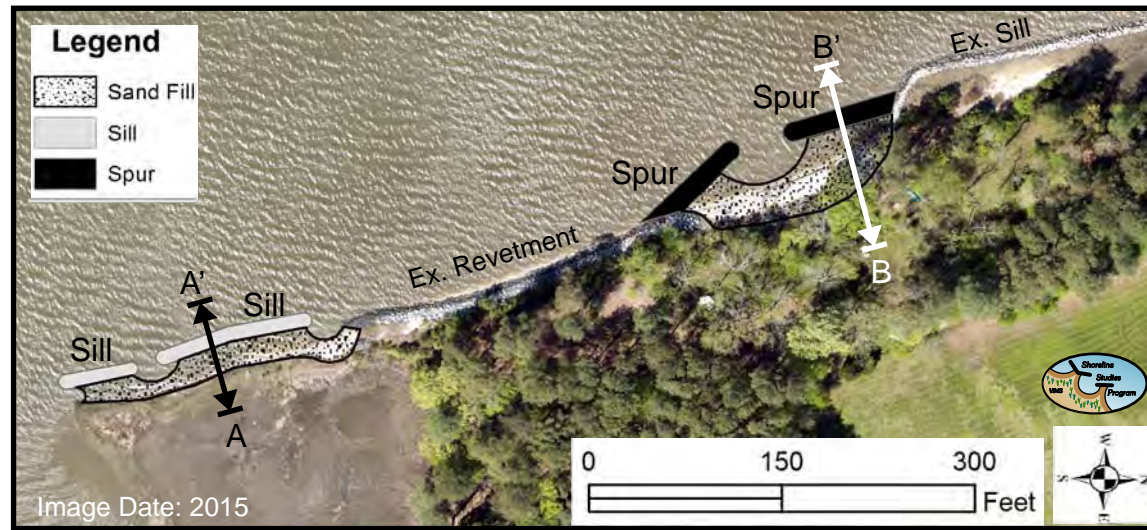
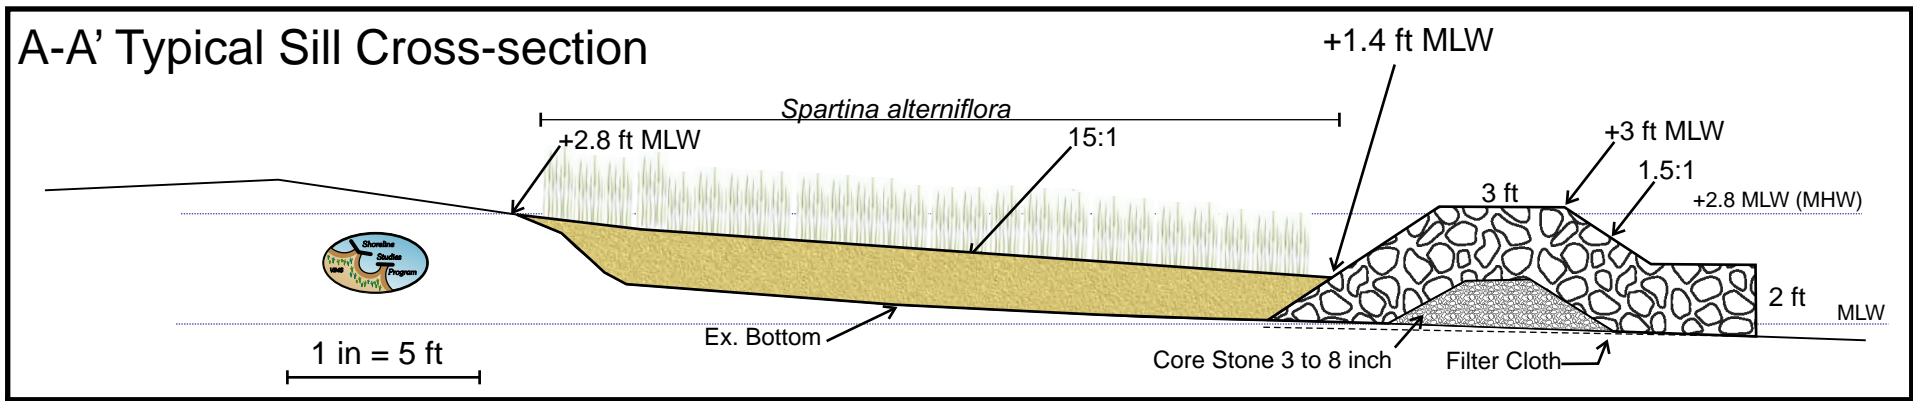
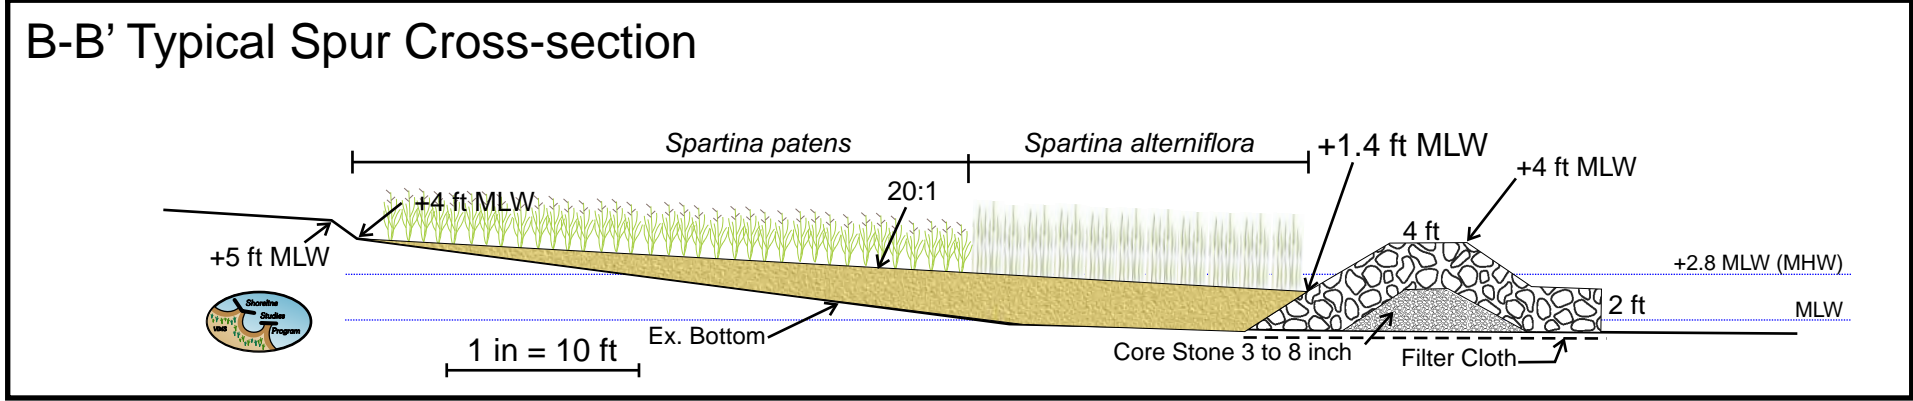
Figure 11. Top: Planform showing the recommended shore protection strategies for the southern end of Werowocomoco's York River shoreline. Bottom: Typical cross-sections for the recommended structures.

On the southern end of the reach, the existing marsh is eroding and wide tidal flats occur (Figure 12). Two gapped sills, 75 feet and 125 feet, 12 feet wide, and 3 feet high are recommended (Figure 11). Sand will be placed behind the structures which will be planted with *Spartina alterniflora* and *Spartina patens*. Access to this site should not be an issue since the bank is sloped in this area.

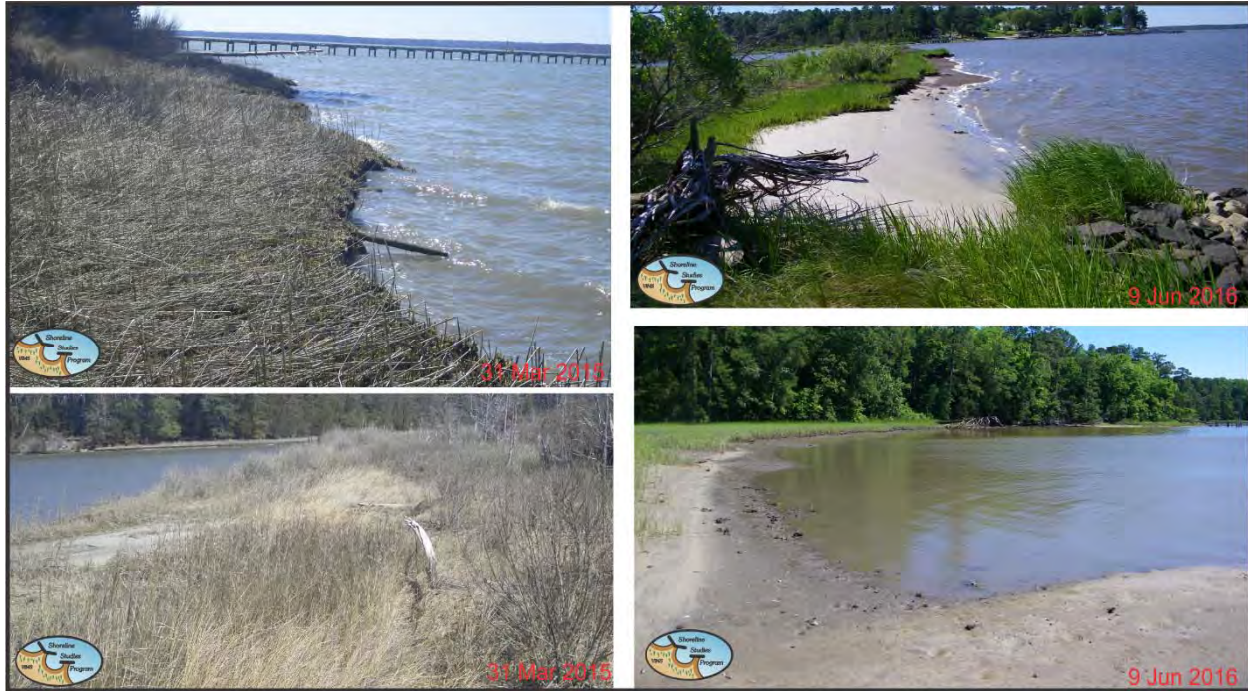
Figure 12. Existing conditions (left) along the northern section of the reach at Leigh Creek and (right) along the southern section of the reach at Bland Creek.

The marsh along the northern section of the York River property is extensive but has an eroding scarp (Figure 12). A series of five gapped sills are recommended along this shore reach. The structures vary between 130 feet and 200 feet long. They are 12 feet wide and 3 feet high (Figure 13). Sand will be placed behind the structures which will be planted with *Spartina alterniflora* and *Spartina patens*. Access to this section of shoreline might be difficult because there is a possibility that the Native American burial ground may occur on the adjacent upland.

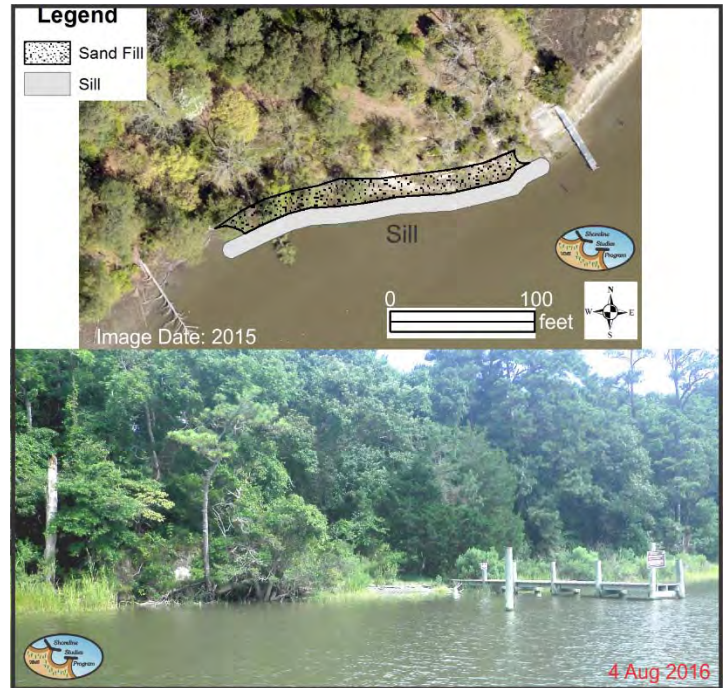
Figure14. Top: Recommended living shoreline protection along Bland Creek. Bottom: Existing conditions of the shoreline. Intermittent fringe marsh exists, but the bank is eroding.

The shoreline along Bland Creek would also benefit from a living shoreline. A 230 foot sill along the eroding upland would protect the bank (Figure 14). Depending on the NPS planning process, the adjacent area could potentially be used for a kayak launch site.

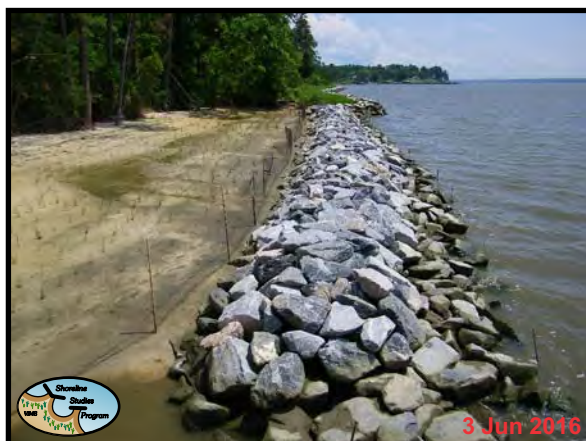
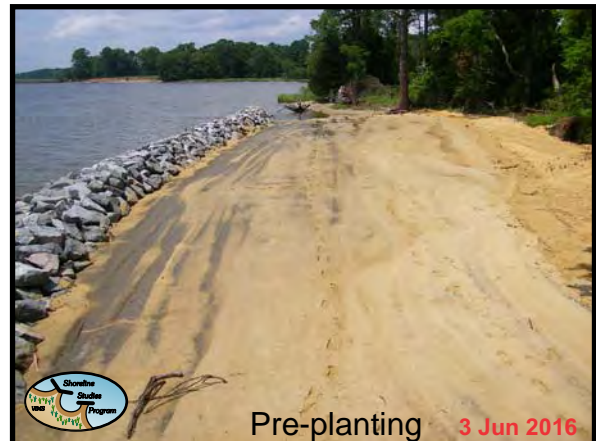
Post-Construction Shoreline

This Living Shoreline project consists of two sills (152 feet and 170 feet long) with one window (25 feet wide). The southern sill was attached to an existing higher, continuous sill. Sand fill was placed behind the structures and planted with marsh grasses on a two foot grid. The upper elevation of sand fill was set at +5.0 ft MLW to interface with the eroding bank, and extends on a 12:1 slope to about mean tide level at the back of the proposed stone sills. Once established the project will provide an erosion-control marsh fringe and protect the base of bank from erosion.
