Living Shoreline Professionals Advanced Training

**MARSH SILL DESIGN
CASE STUDIES**

Occohannock on the Bay

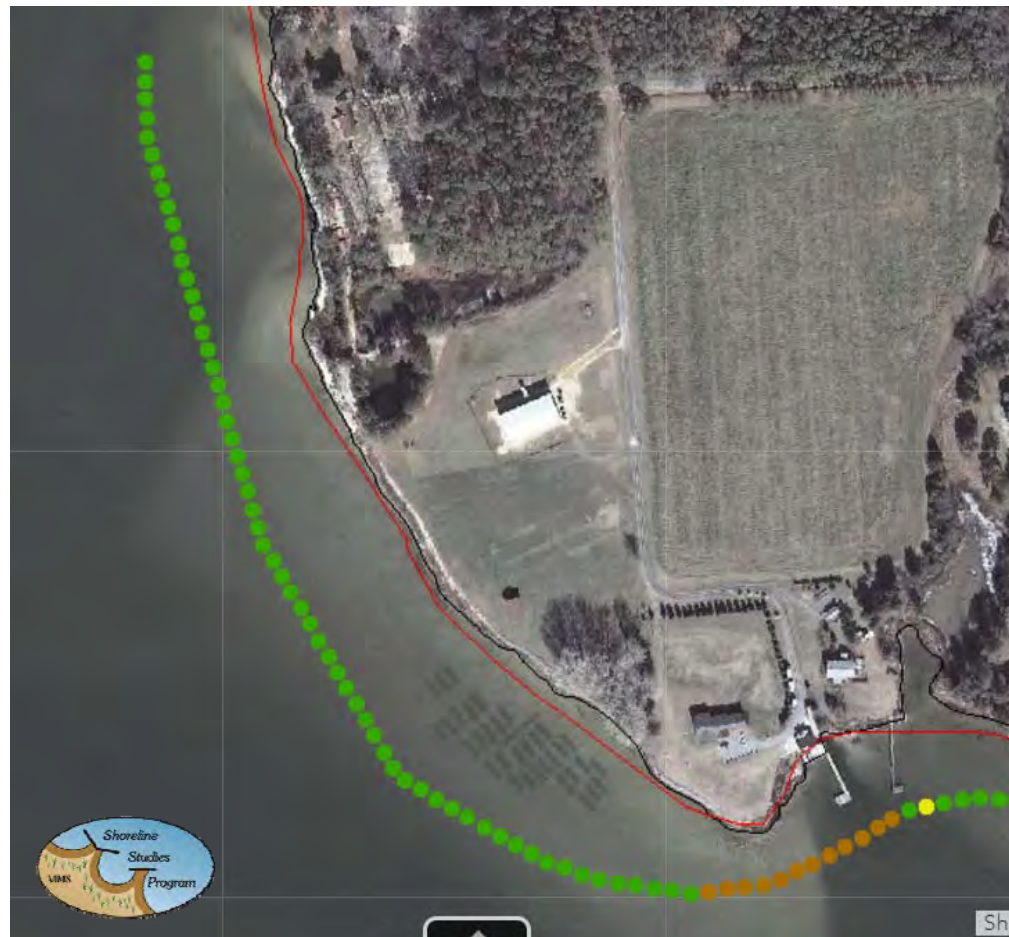
Shoreline Change

Shore Change Data: 1937 to 2009

1937/38 Shoreline

2009 Shoreline

Most of the shoreline had a long-term very low erosion rate.

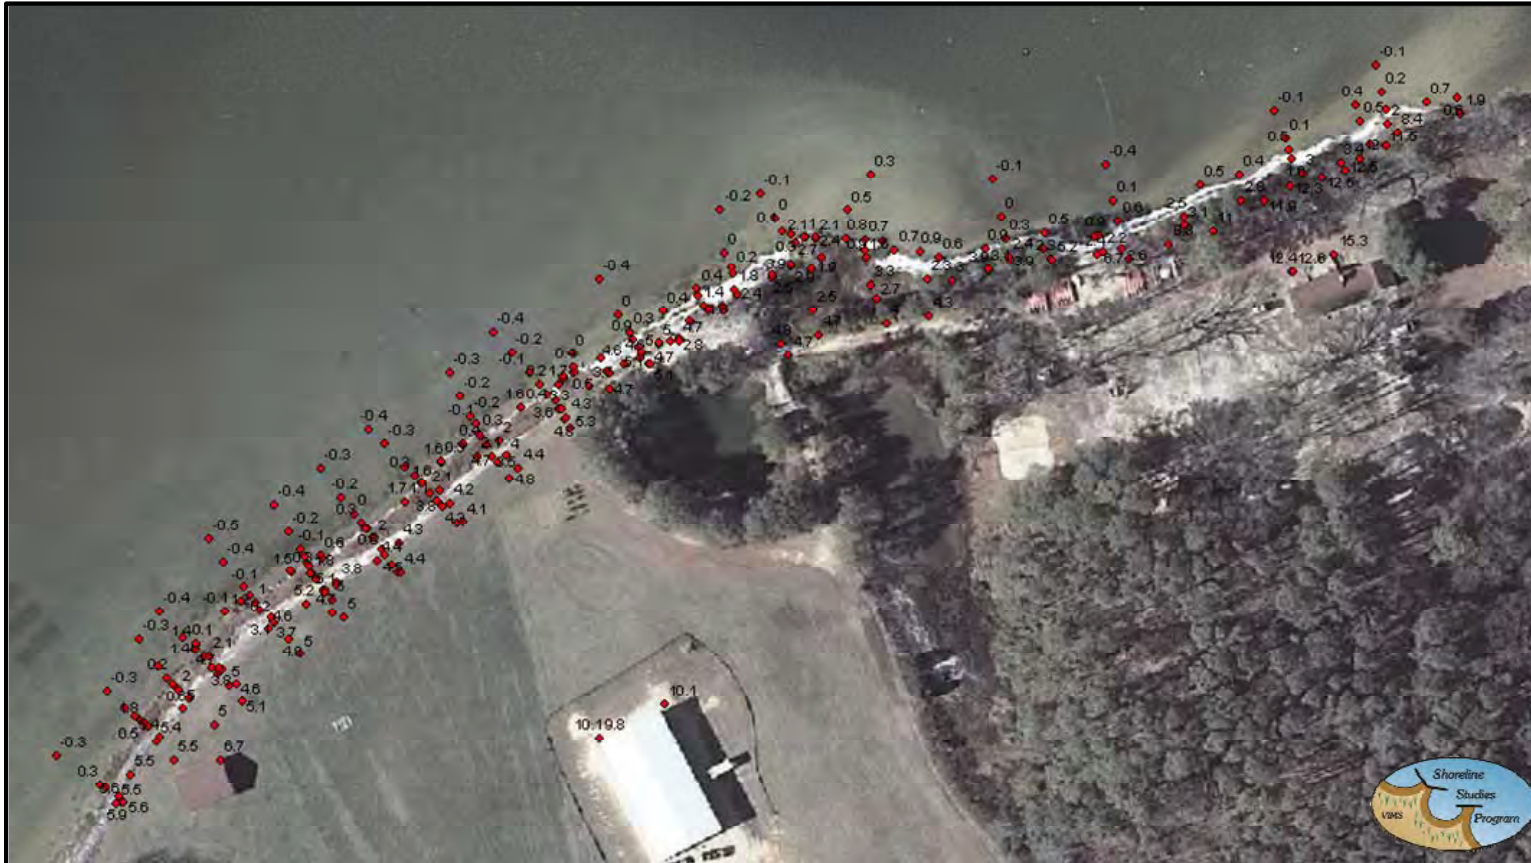
Shore Survey

The site was surveyed with a real-time kinematic global positioning system and a robotic total station because this was a research project in addition to a design project. Generally, a survey does not need to be as detailed for a project site. It is important to determine the elevation of the bank, especially if it will be graded, the nearshore depth, intertidal gradients, existing wetlands and SAV, and tide level.

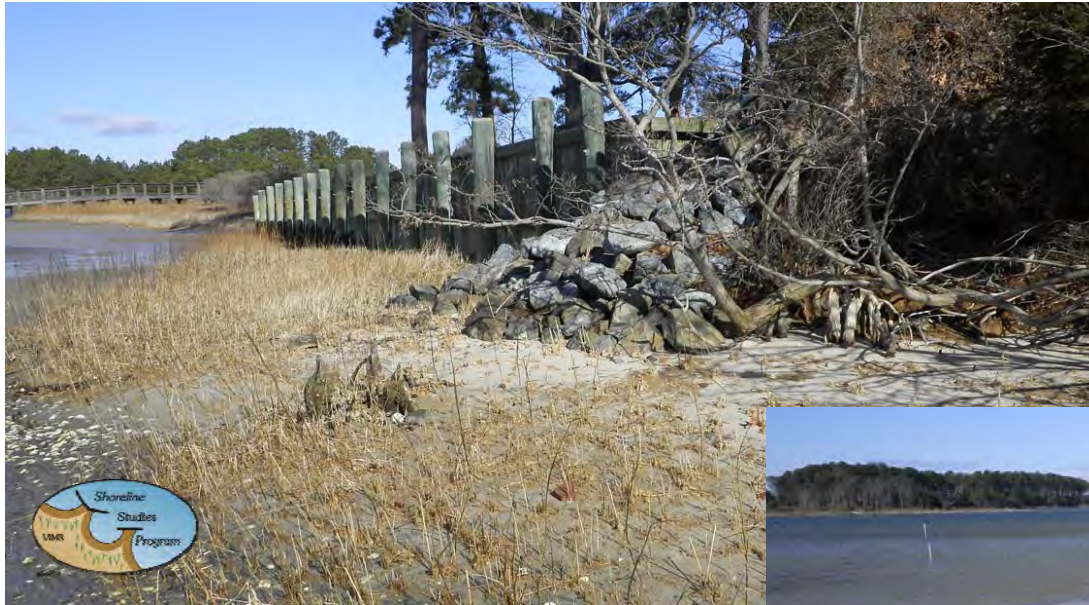
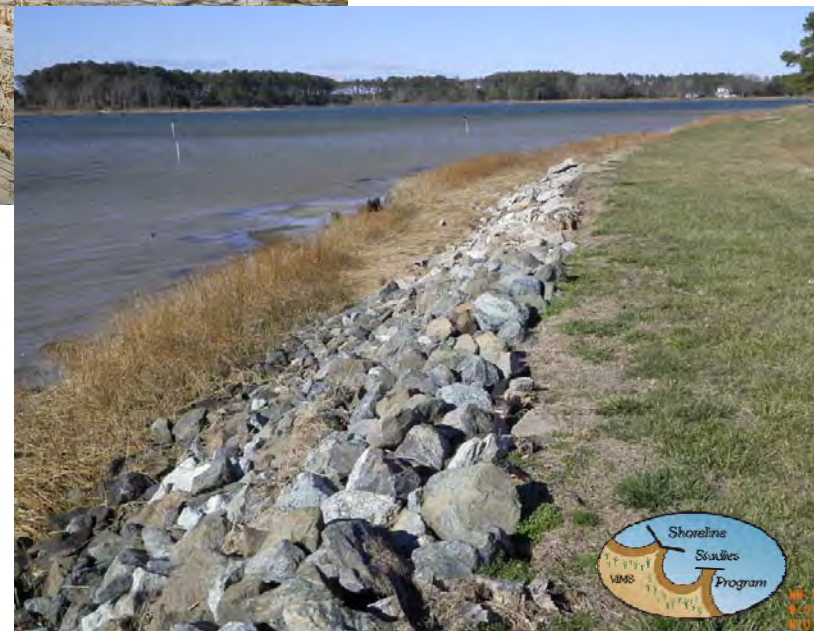
Existing Structures

North End:
Stone placed at the
end of a bulkhead
that was being
flanked.

South End:
Revetment placed
along the eroding
upland with a
narrow marsh in
front.

Existing structures that had to be considered in the design process. Photo date: Jan 18, 2012

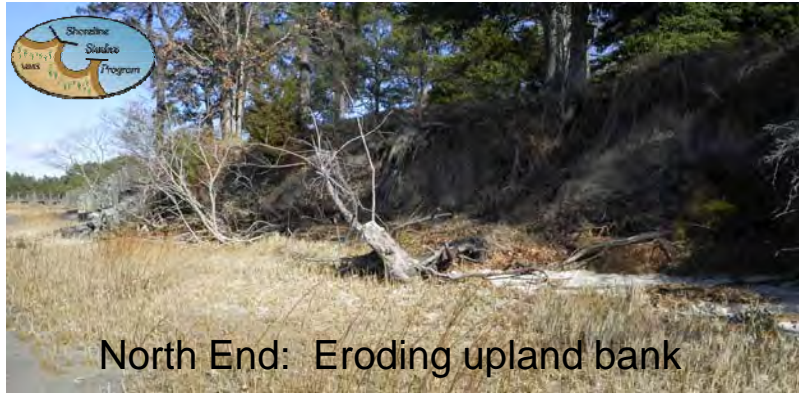
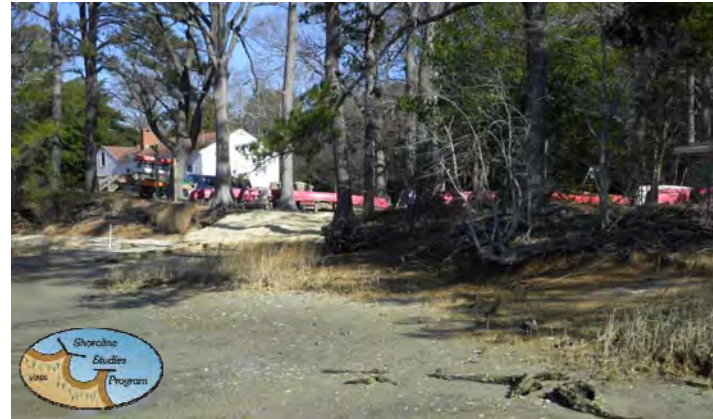
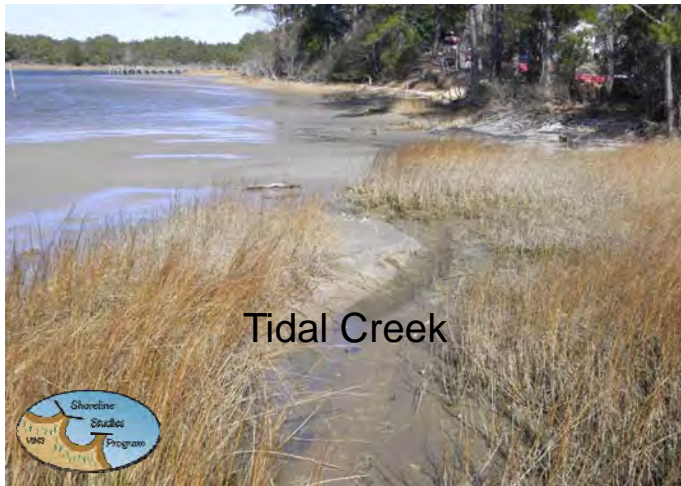
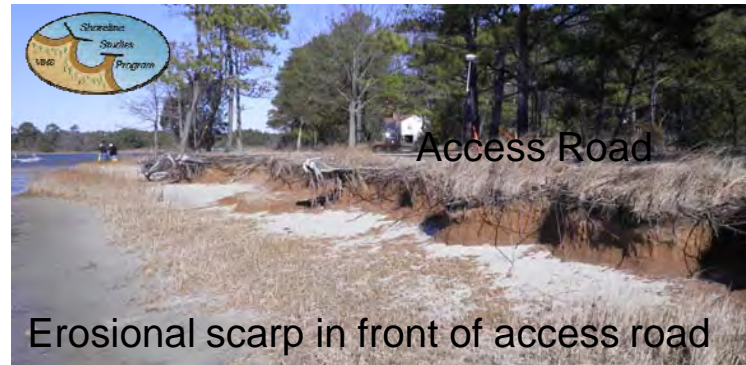
Existing Conditions

North End: Eroding upland bank

North End: Eroding bank & recreation area

Tidal Creek

Access Road

Erosional scarp in front of access road

Additional considerations were the eroding upland bank, the kayak launch and recreation area, the tidal creek outlet and the access road.

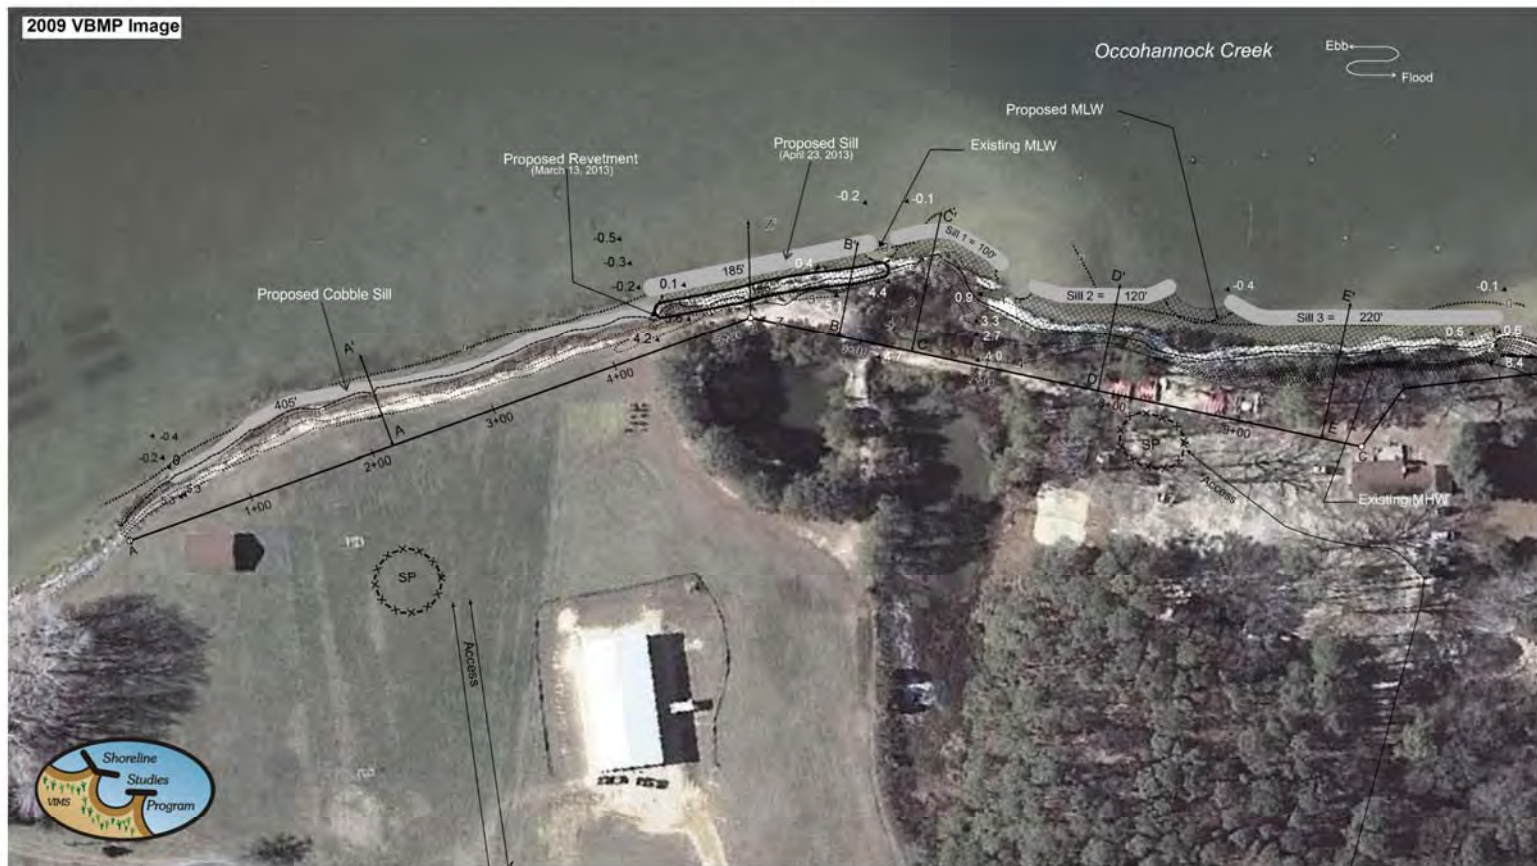
Design

For the permit application, the conceptual design included three sills and a revetment along the most highly eroding section of shoreline. The gaps were spaced to allow for the tidal marsh channel to exit into the creek. In addition, the sills were angled to create more of an embayment between sills 2 and 3. This allowed for use as a canoe launch.

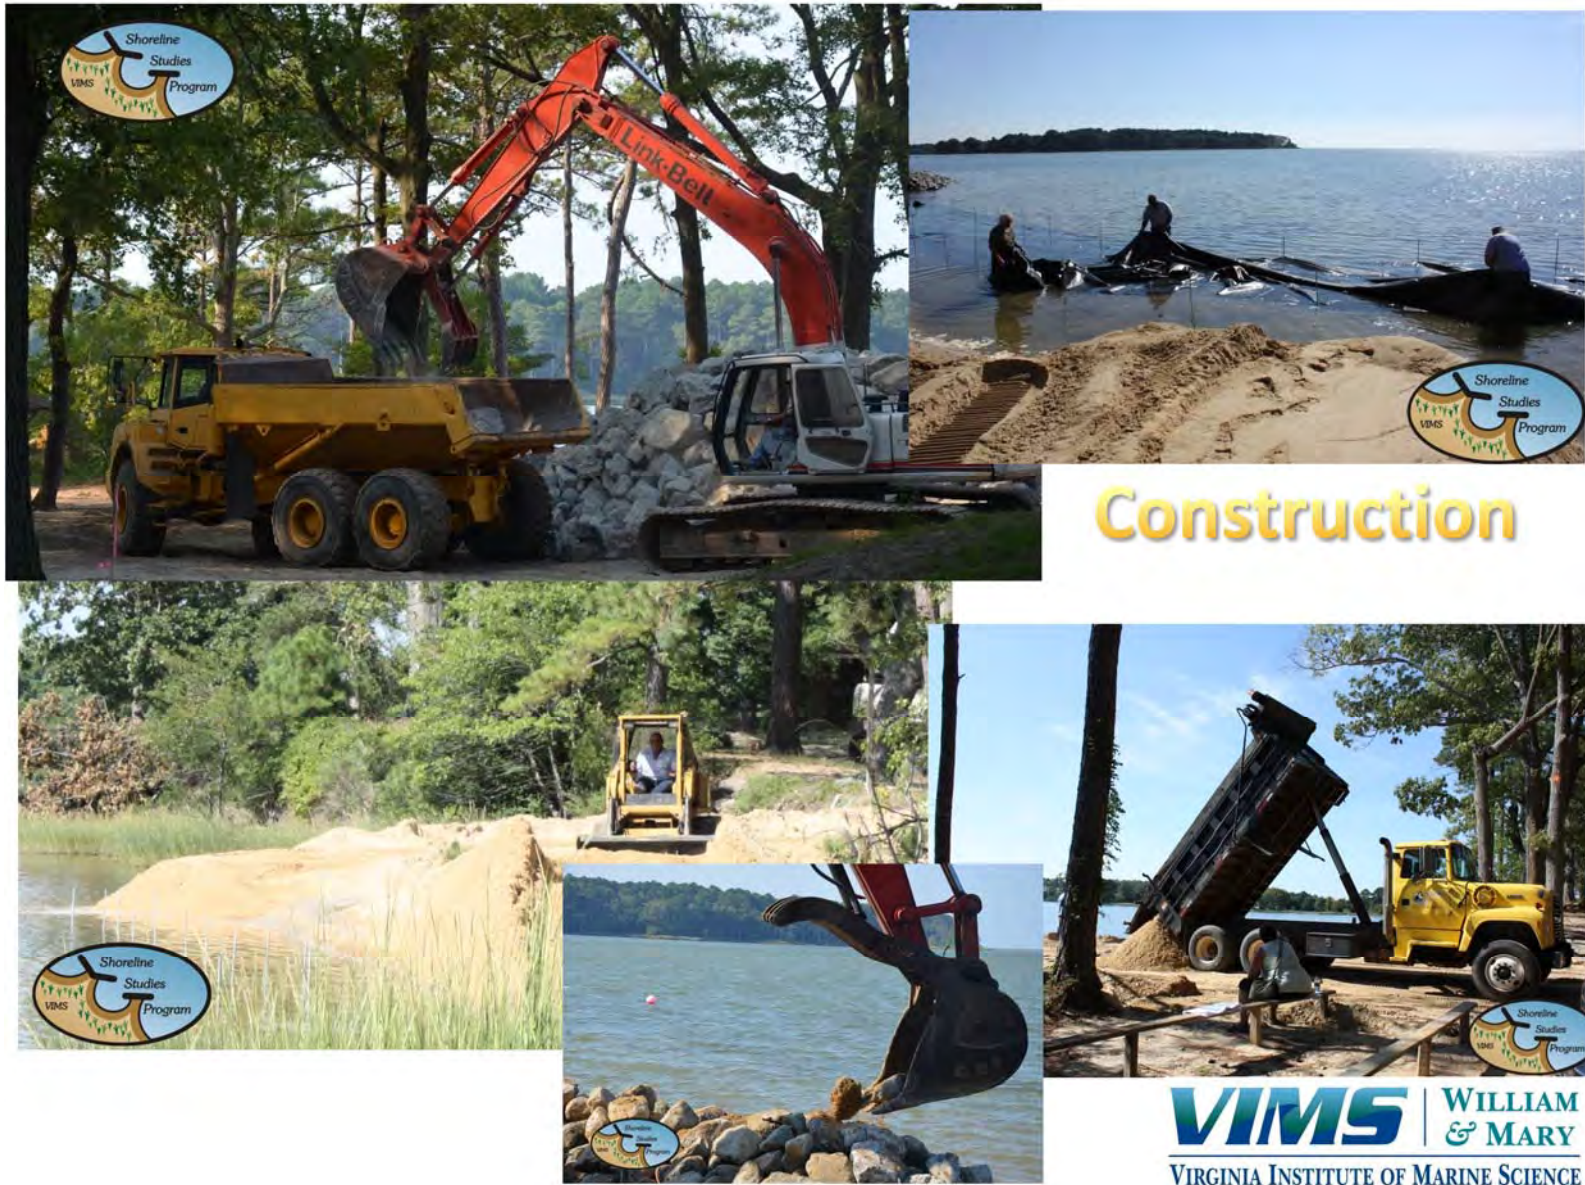
Construction

- Top Left: Loading rock onto site truck
- Top Right: Installing filter fabric
- Lower Left: Placing beach nourishment
- Lower Right: Bringing in sand material

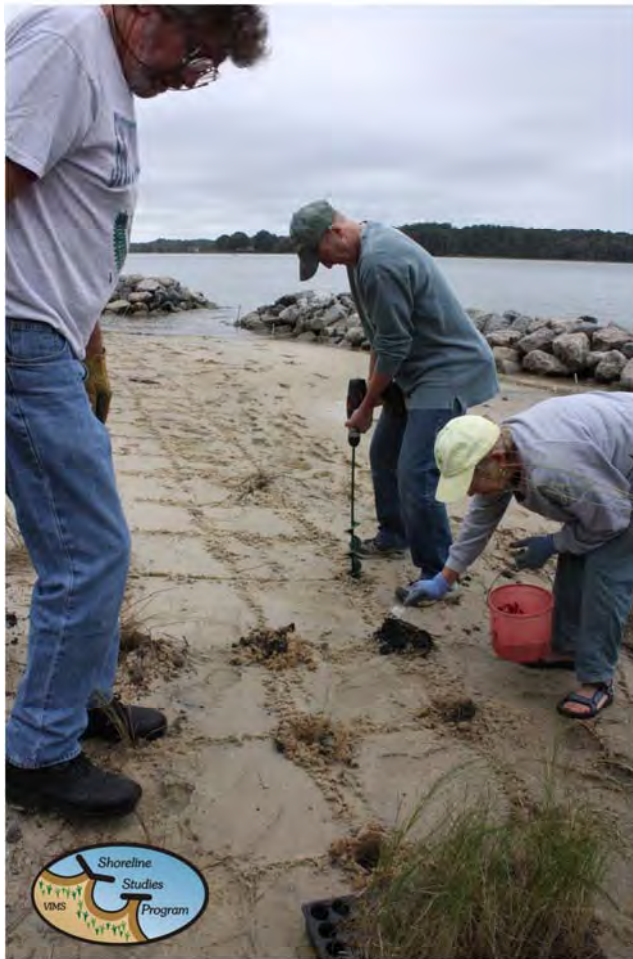
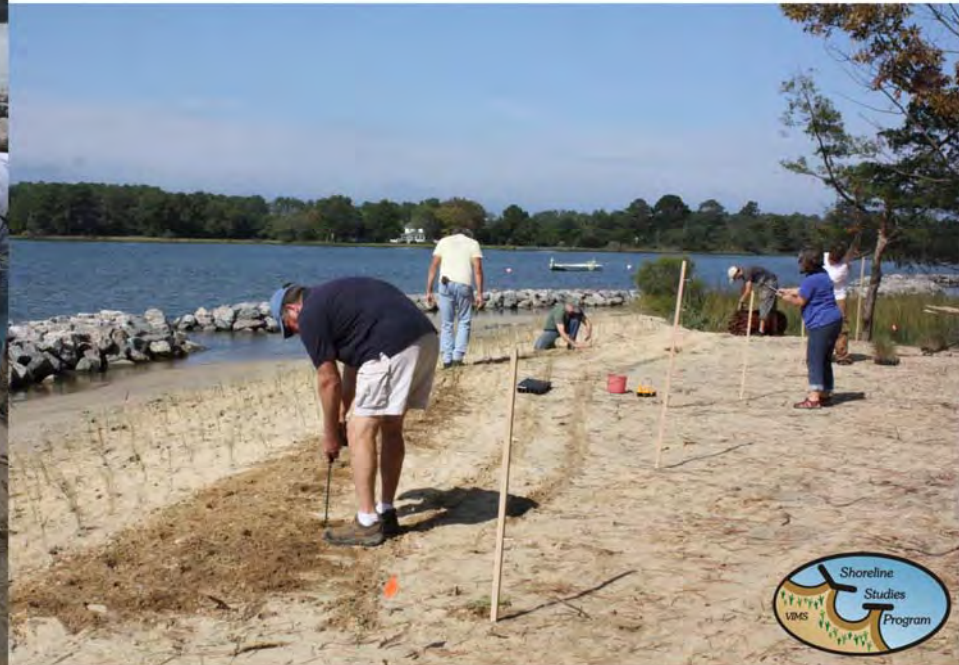
Planting Marsh Grass

Volunteers planting marsh grasses on a 1.5' x 1.5' center. Steps include drilling the planting hole, adding fertilizer, installing peat pots/plants, and healing in each plant.

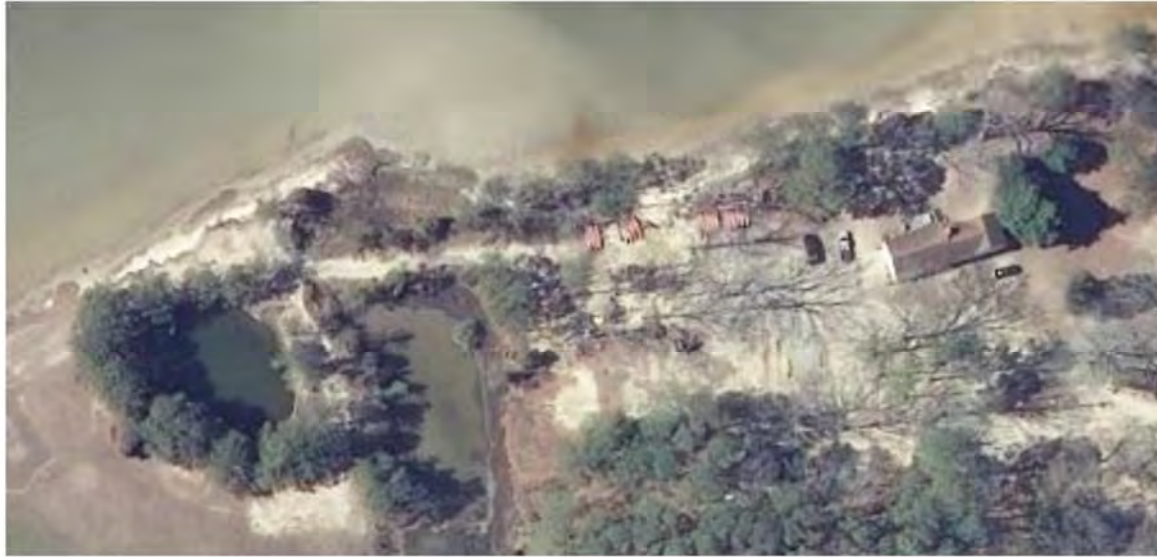
Pre & Post Construction

2013 VBMP Imagery

2014 NAIP Imagery

The project was completed in 2014.

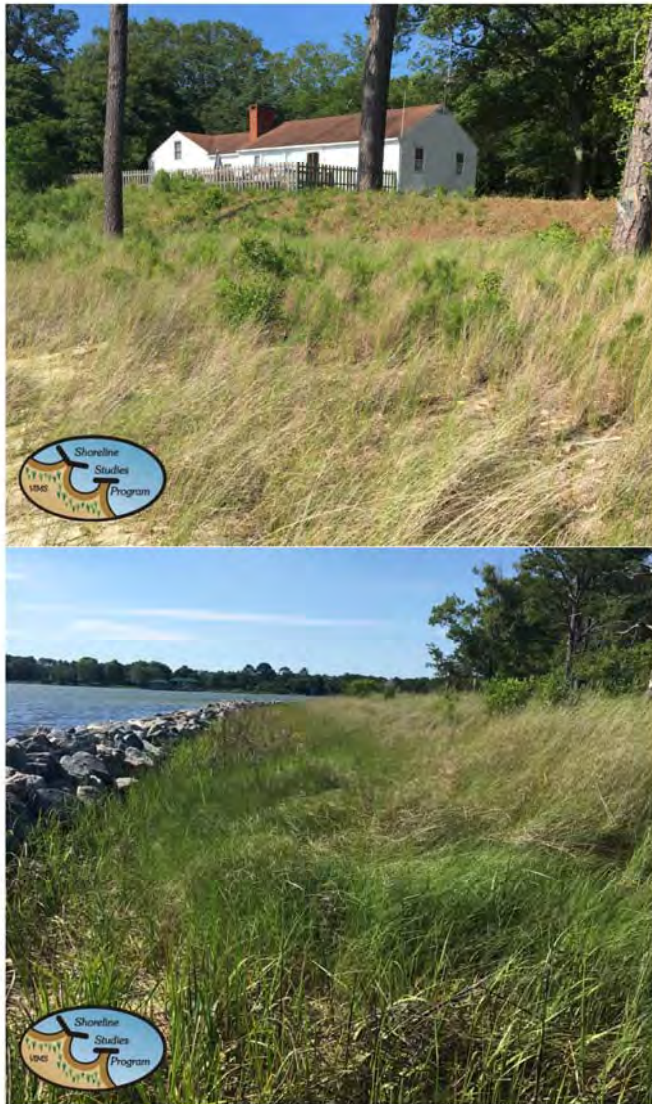
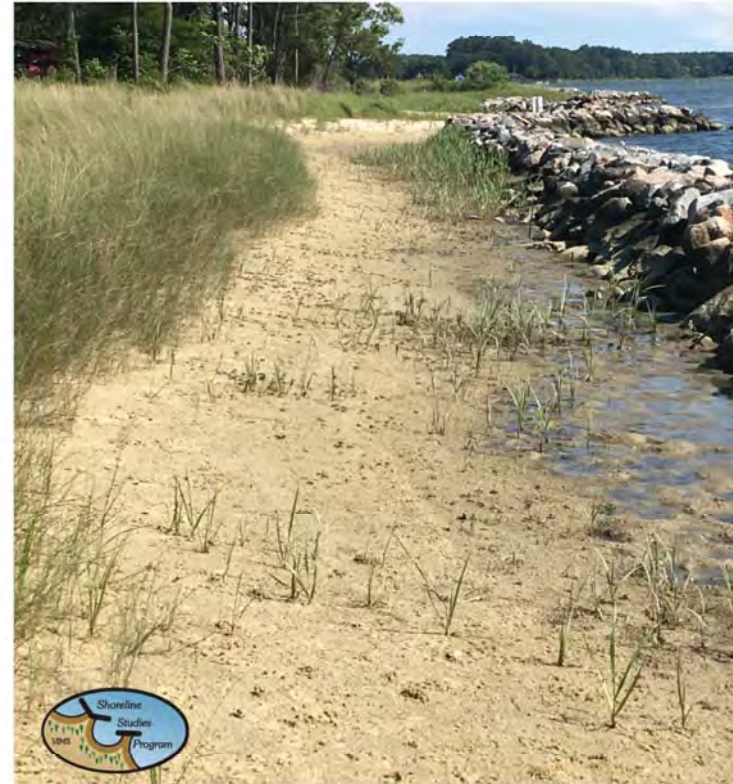
May 2017

After three growing seasons, the grasses have generally fared well at the site. Areas of marsh are lush and other plants (pine trees) are beginning to colonize the upper marsh and upland transition zone. However, one section of low marsh behind Sill 3 remains bare.

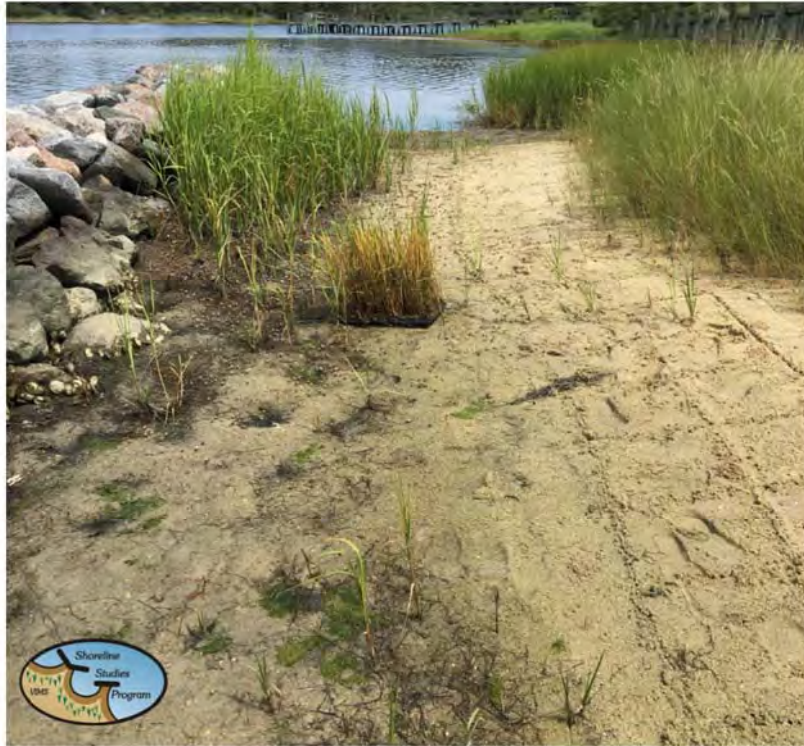
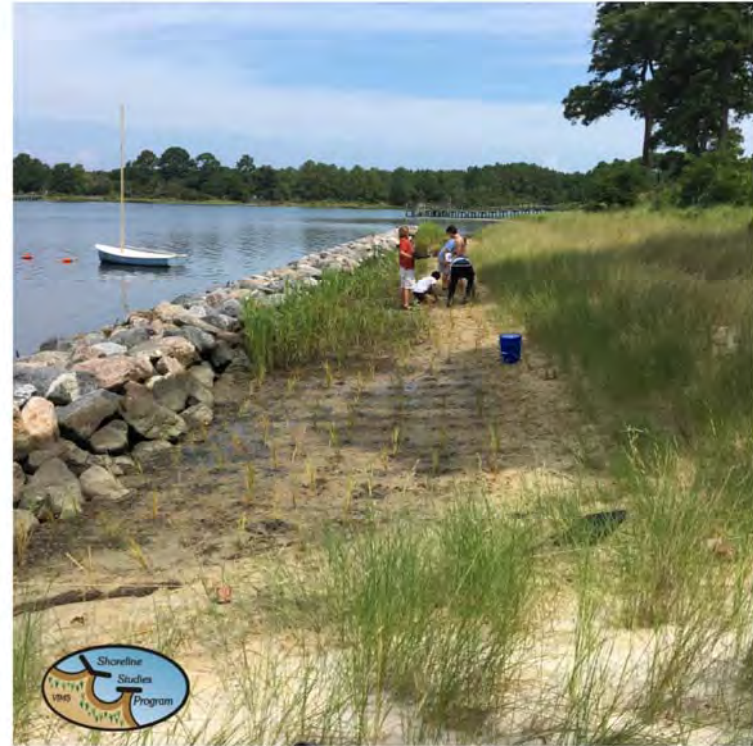
Replanting – July 2017

The bare spot was a concern so additional plants were planted in July 2017 and will be monitored to see how they fare.

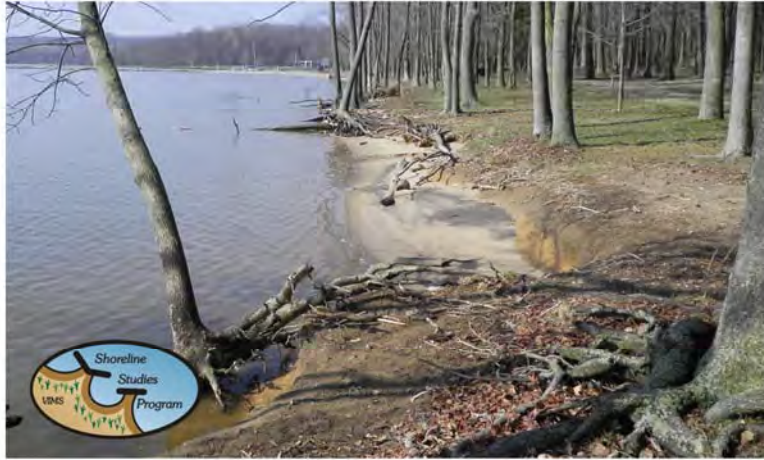
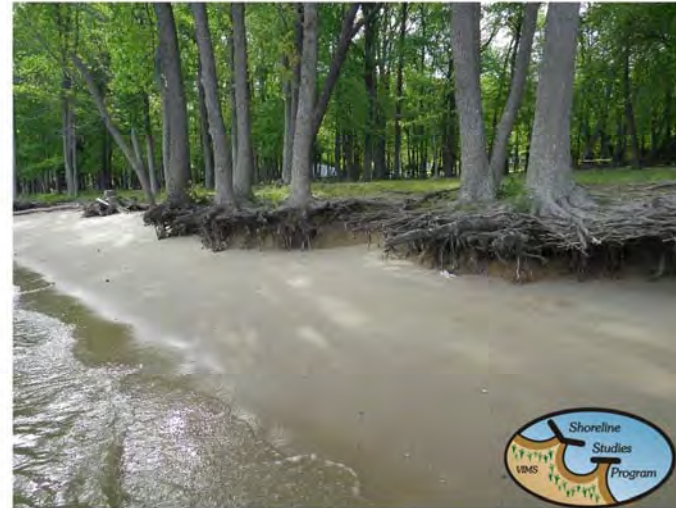
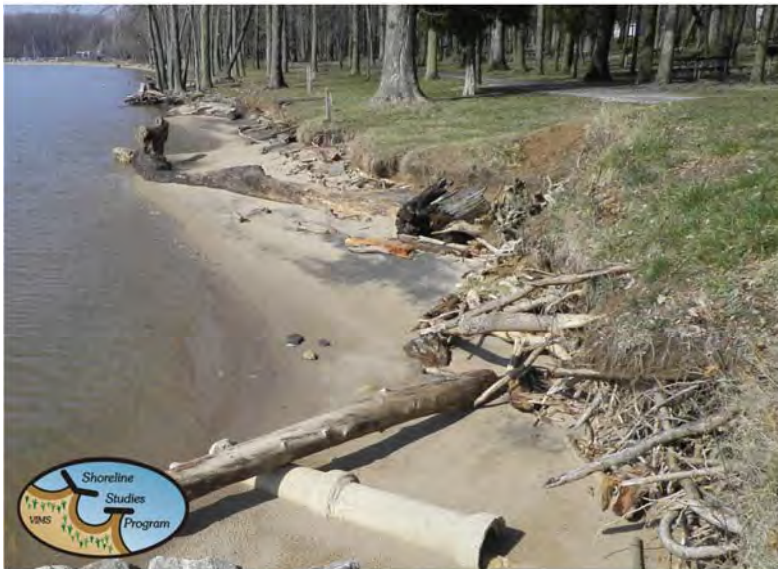
Existing Conditions

Erosion destabilized about 800 ft of shoreline on the Potomac river and threatened walkways and picnic areas. In addition, mature trees have to be removed every year because of exposed roots and safety concerns. Active erosion and stormwater runoff from upland areas contributes large amounts of fine sediments to the river. The area was unsafe for park users.

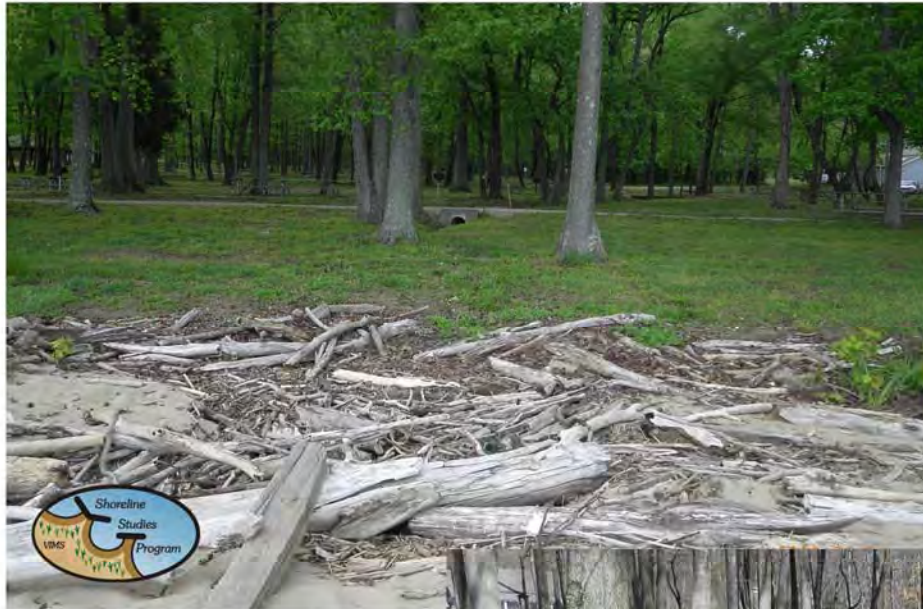
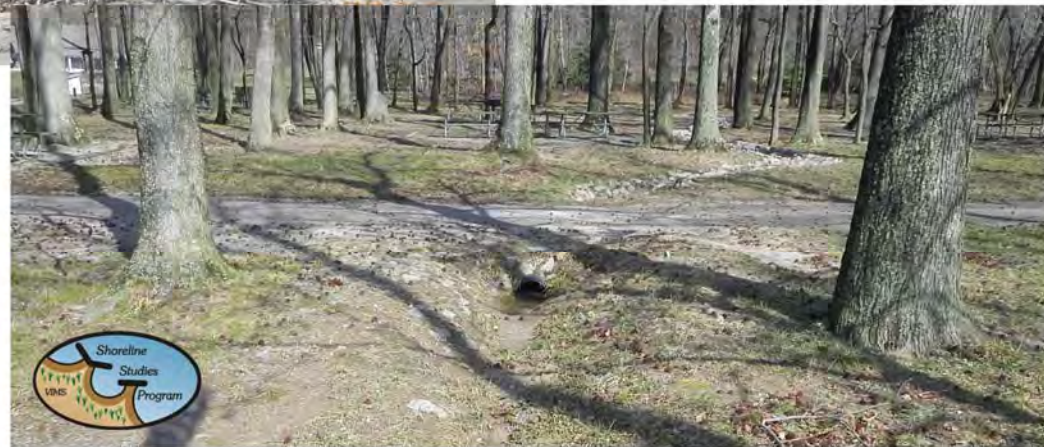
Maintenance & Upland Runoff

Maintenance will be a long-term issue for this site as logs wash up regularly along the shoreline. These will need to be removed from the marsh or it will kill the plants. Upland runoff was a consideration for this site because it is channeled and piped at the site.

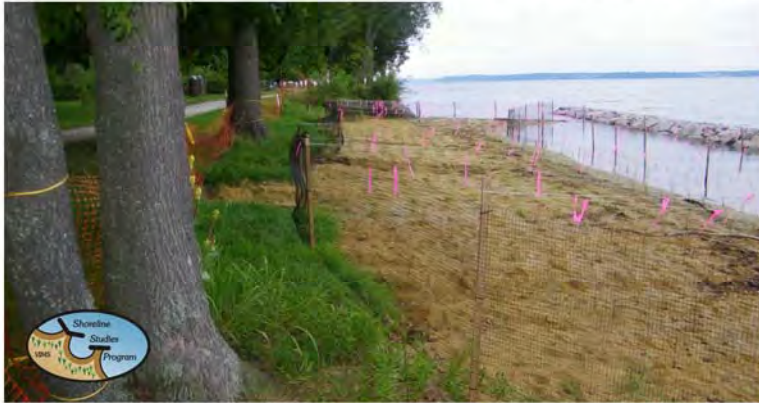
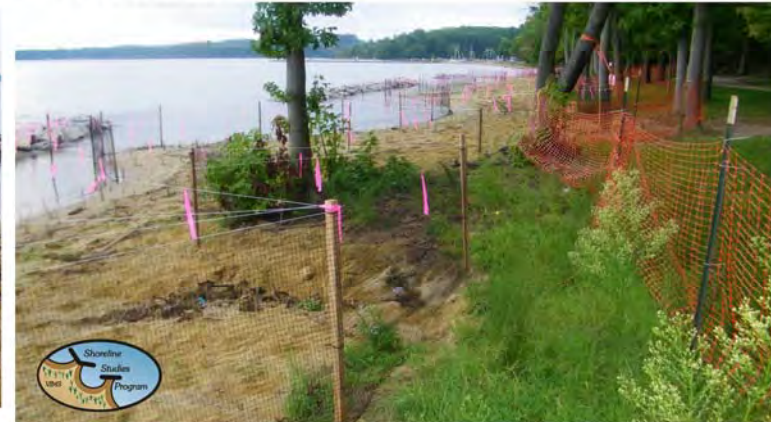
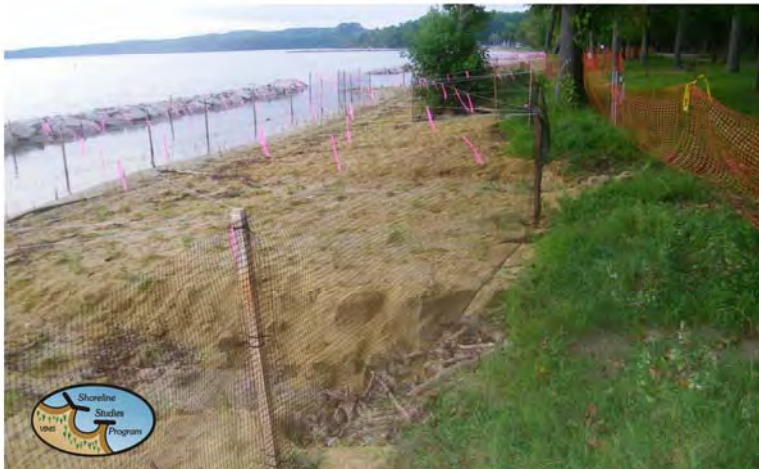
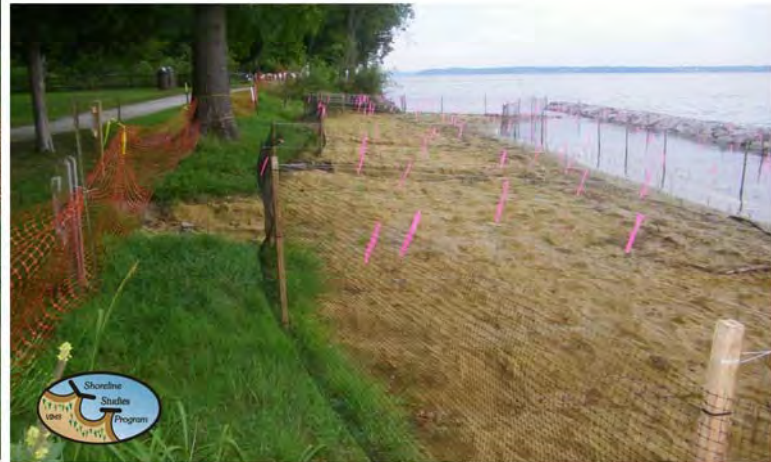
Post Construction

The project was built in summer 2016. Upland runoff is indeed an issue at the site as shown in these post-construction photos top right and bottom left. Erosion of the placed sand fill occurred.

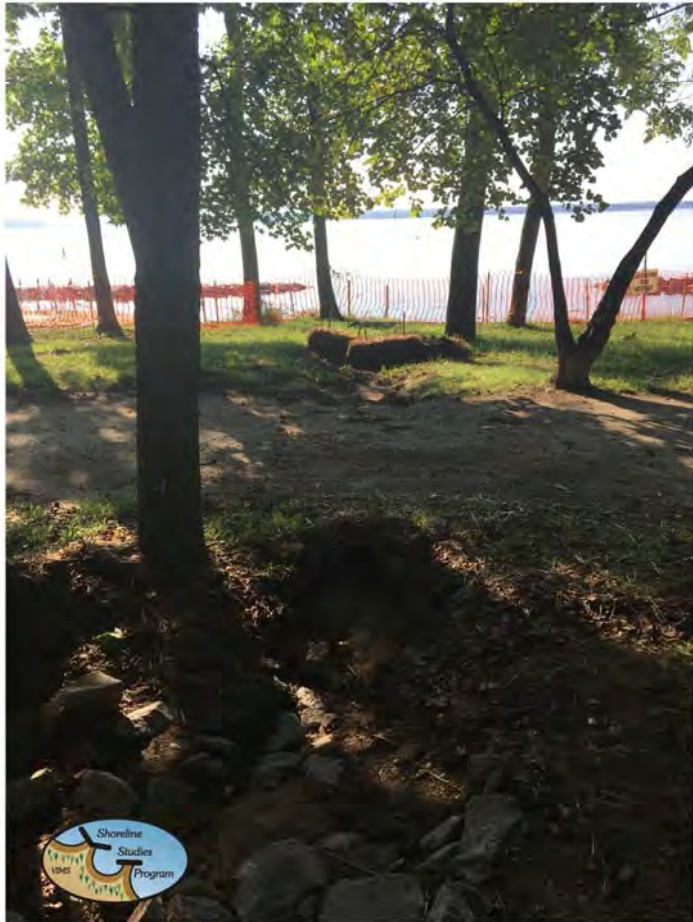
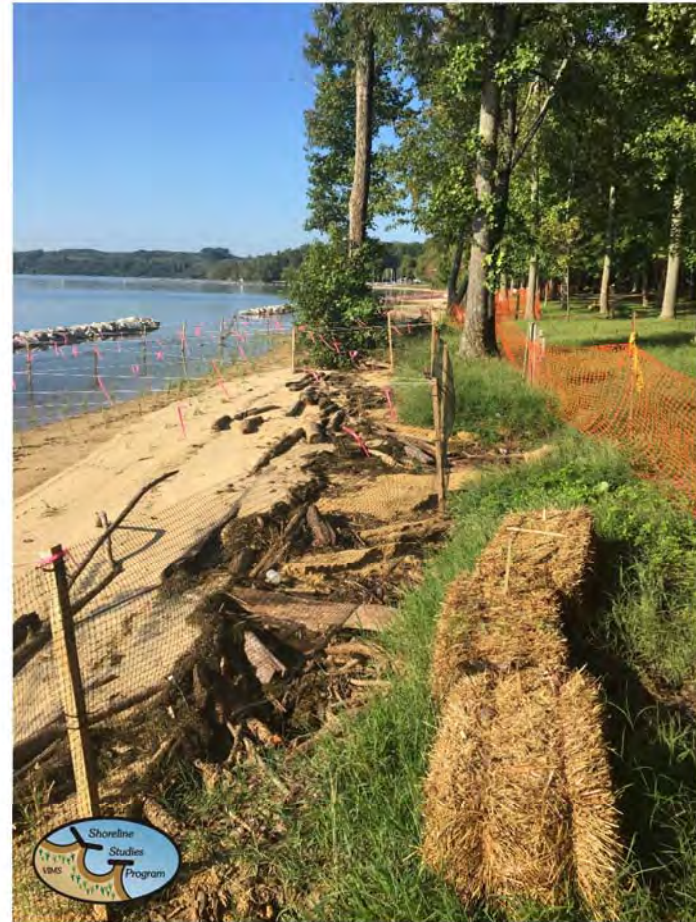
Upland Runoff Erosion Control

To address the upland runoff, hay bales were placed along the shoreline to slow the water before it impacted the shoreline.

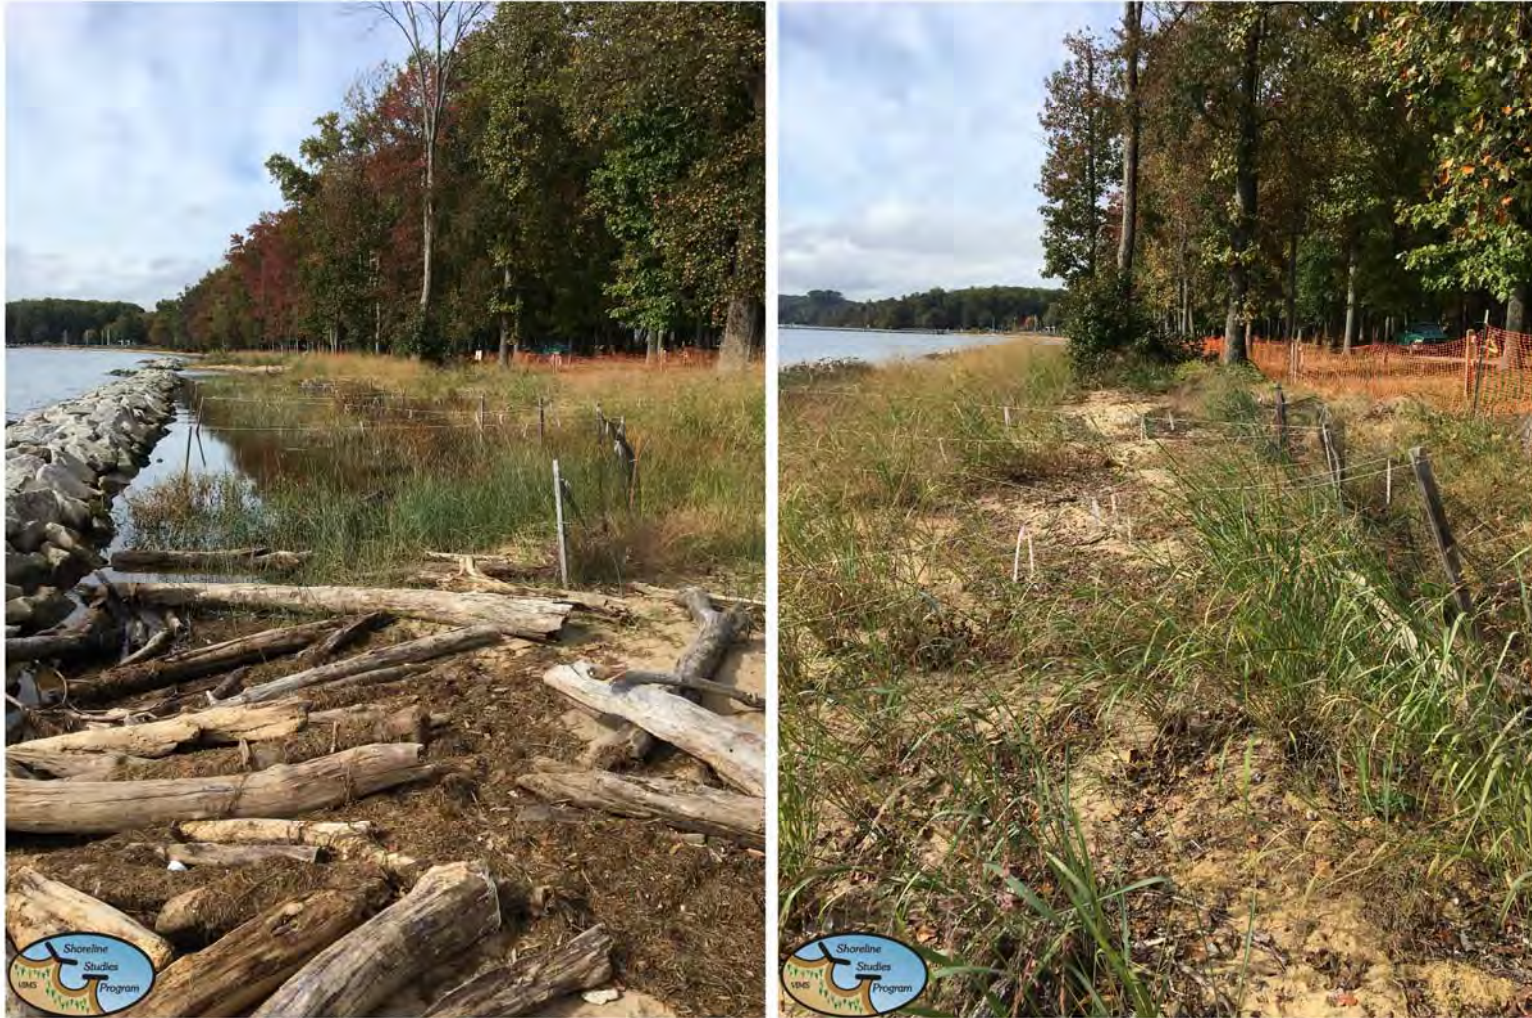
One Year Post Construction

The vegetation has taken hold at the site. There is a low spot behind northernmost sill that is completely submerged. The backshore zone has some bare spots in it, but it should fill in over time as new plants colonize the site. Photo date: 23 Oct 2017.

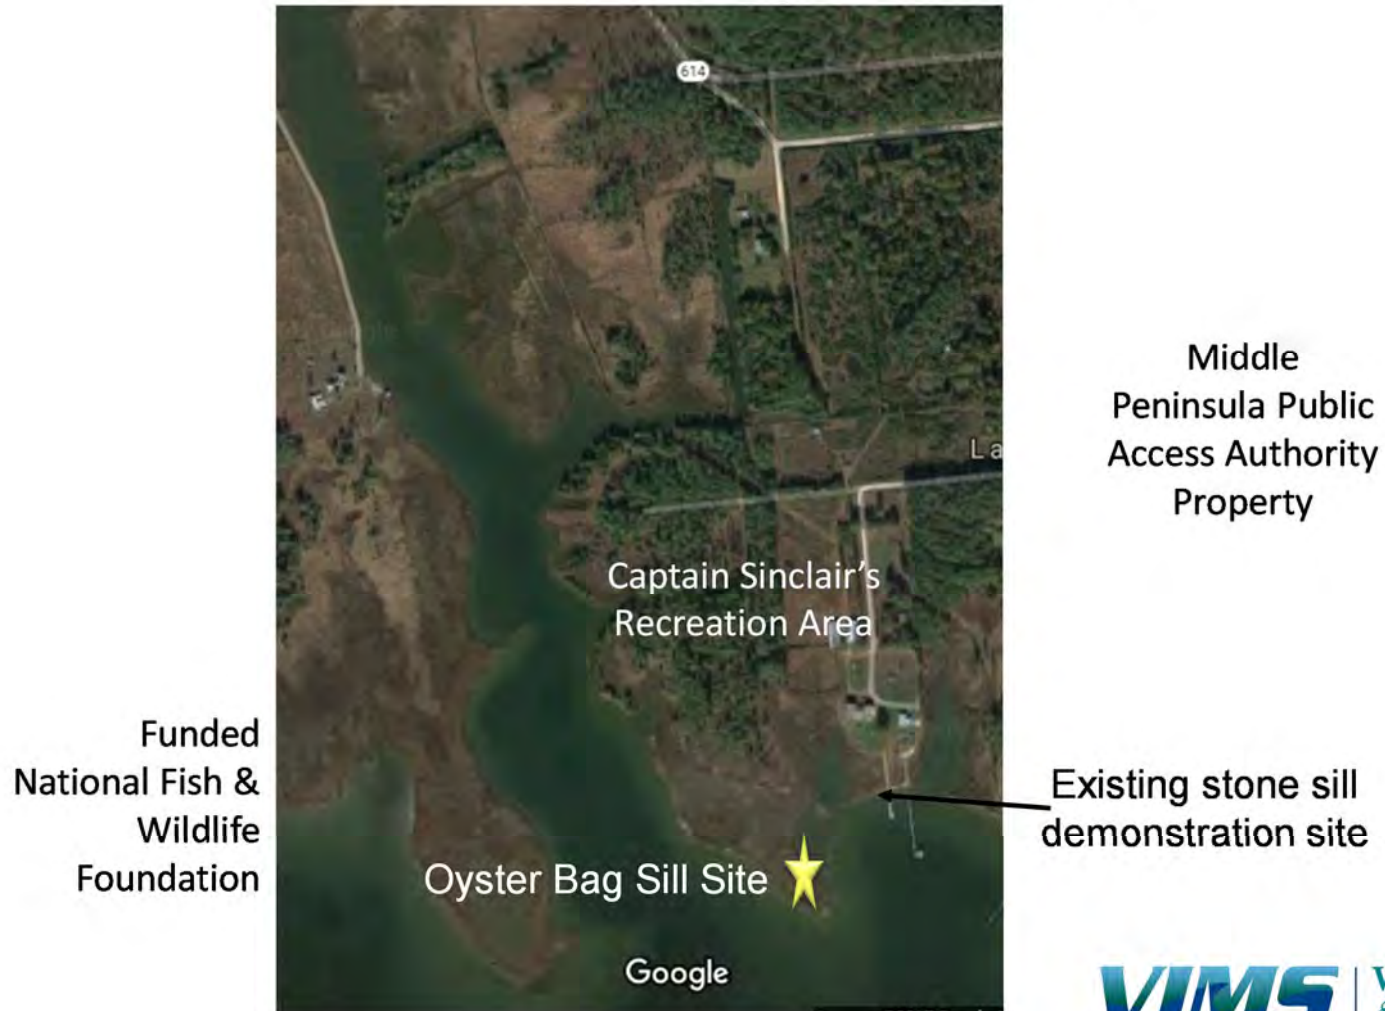
Oyster Bag Sill Construction

Oyster bag sills are a relatively new shore protection method. Oyster shells are packaged in mesh bags which are placed along the shoreline to create a sill. The goal is for new oyster spat to colonize the shell thereby cementing the structure into a reef. Research is presently underway by Shoreline Studies Program on this method. Shoreline Studies Program received a grant from the National Fish & Wildlife Foundation to build two oyster bag sills on public property and monitor the site. This presentation details installation at one of the sites.

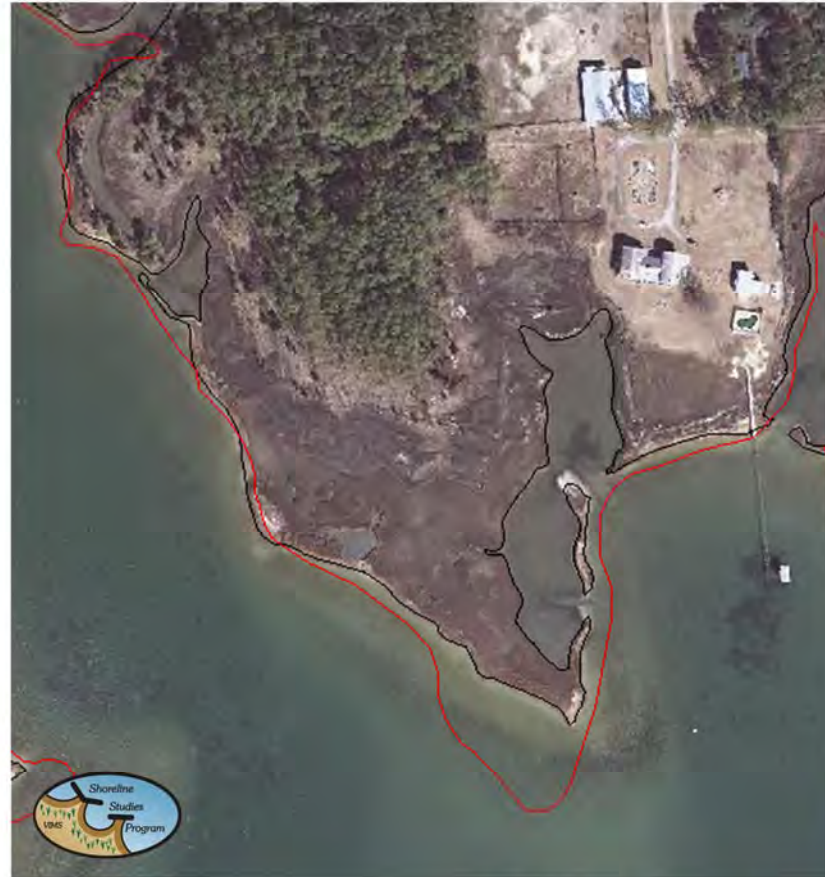
Oyster Bag Sill Construction

- The marsh is eroding rapidly along the point.
- The marsh shoreline is breaking through on the east side.
- Once that happens, erosion will accelerate within the marsh.

The marsh point shoreline is actively eroding at this site. However, it was neither physically nor economically feasible to build a stone structure to protect the shoreline. The shallowness of the site and lack of access for construction as well as the soft nearshore made it an unfavorable site for a traditional rock sill. However, the marsh is an important habitat, and the site is used for recreation including kayaking, fishing, and duck hunting so some sort of protection to reduce erosion was desirable. It was determined that this site would be a good research and demonstration site for oyster bag sills.
