Living Shoreline Professionals Advanced Training

**MARSH SILL DESIGN
CASE STUDIES**

Occohannock on the Bay

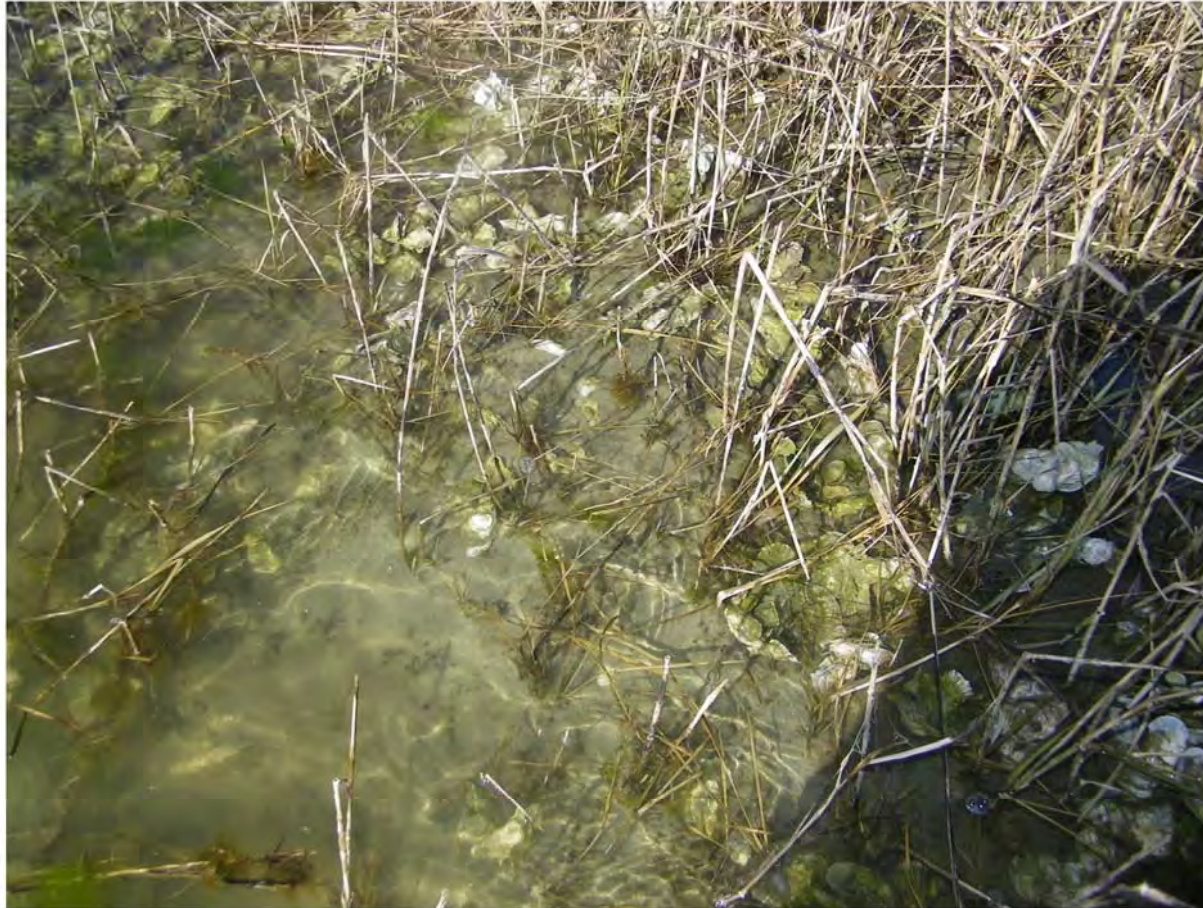
Site Suitability

The marsh at Captain Sinclair has naturally-occurring oysters at the site where the oyster bag sill was proposed. This made it a suitable site because the idea is that spat in the water column will attach to the oyster bags to create a protective reef along the shoreline.

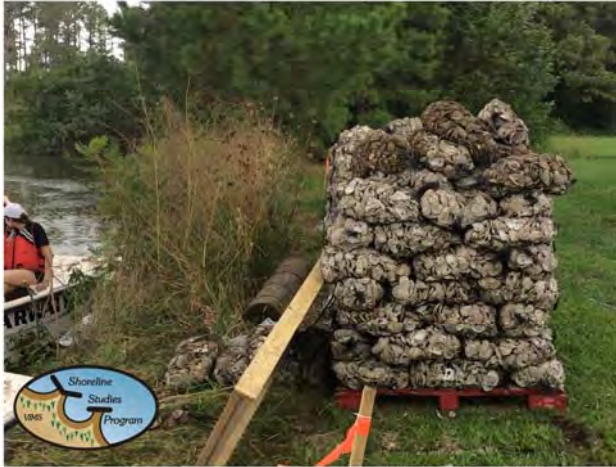
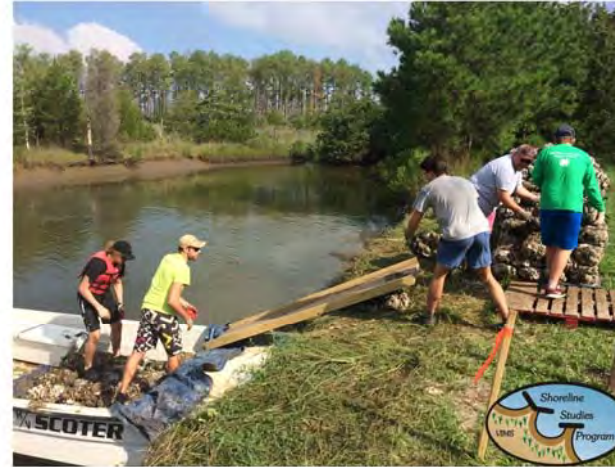
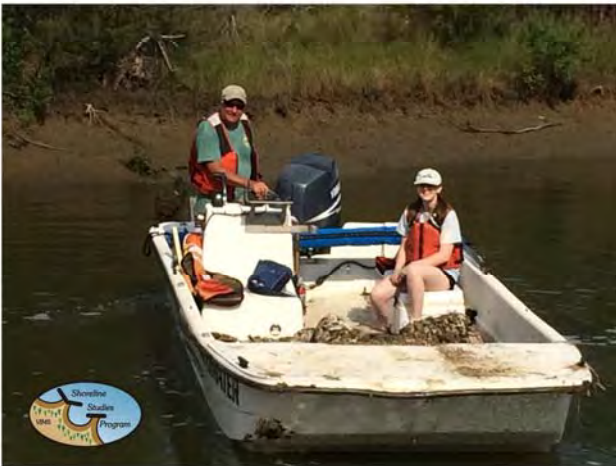
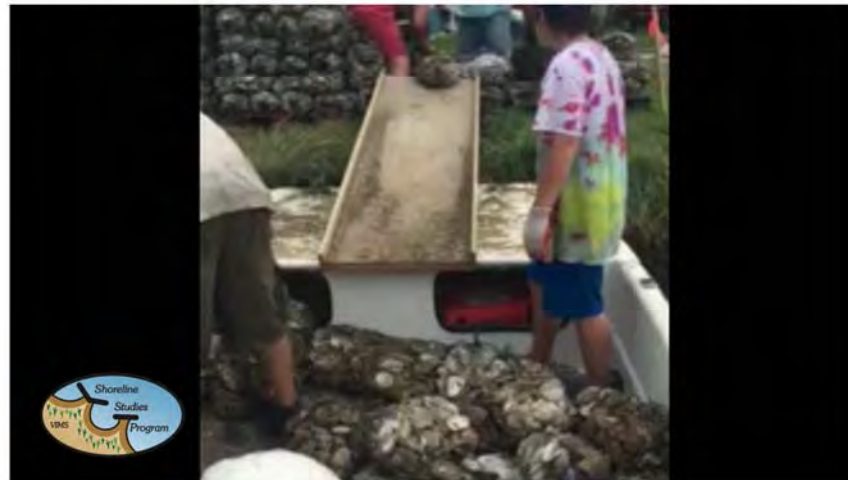
Bag Transport to Site

The pallets of bags were delivered via truck and forklifted to the shoreline. A wooden slide was created to slide the bags into the boats. Once the boat was full, it would deliver the bags to the people building the sill in the water. Each bag weighs about 25 lbs, and this project called for 2,000 bags.

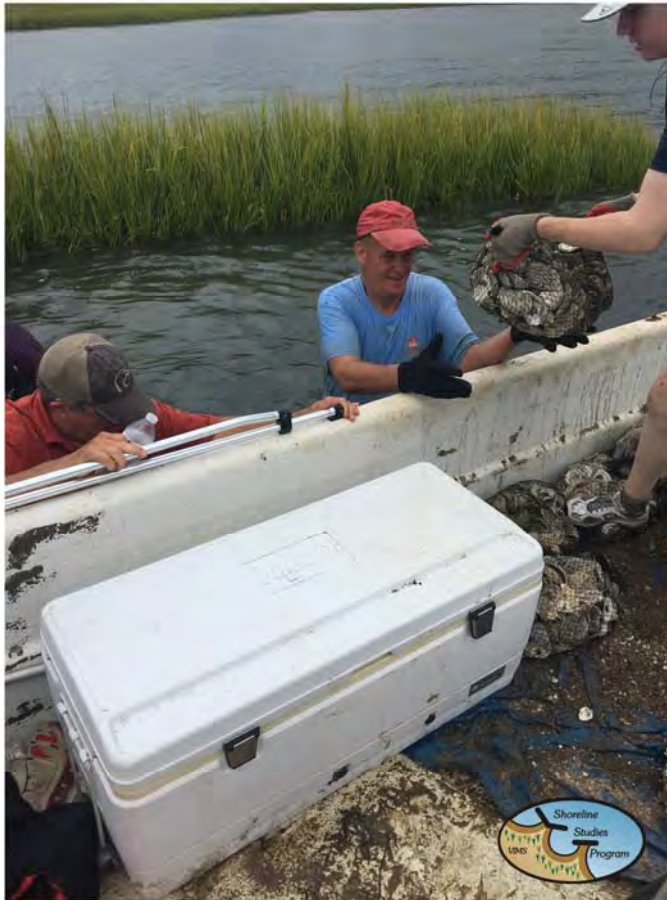
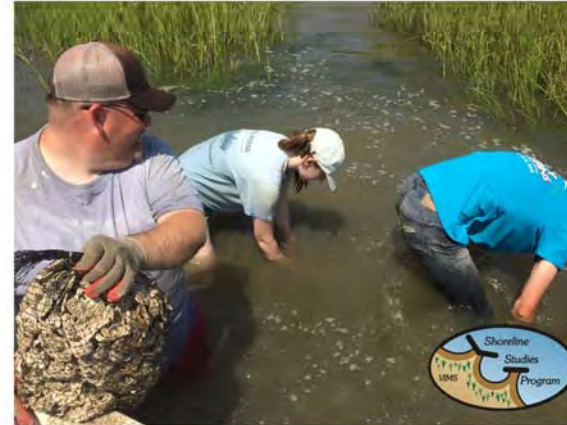
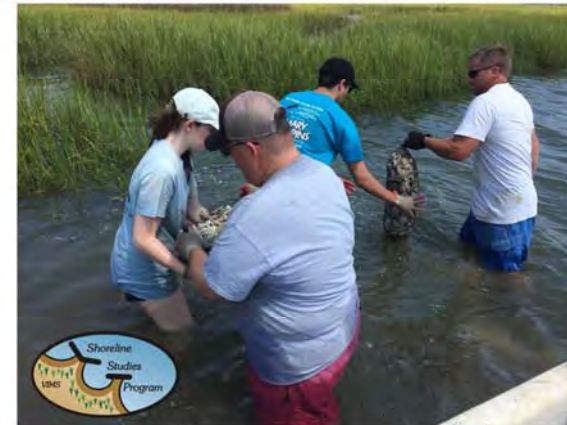
Construction in the Water

The shell bags were handed off the boat to people in the water. One person placed two bags side by side and another person came behind and placed the bag on top. Photo dates: Aug 15-16, 2017

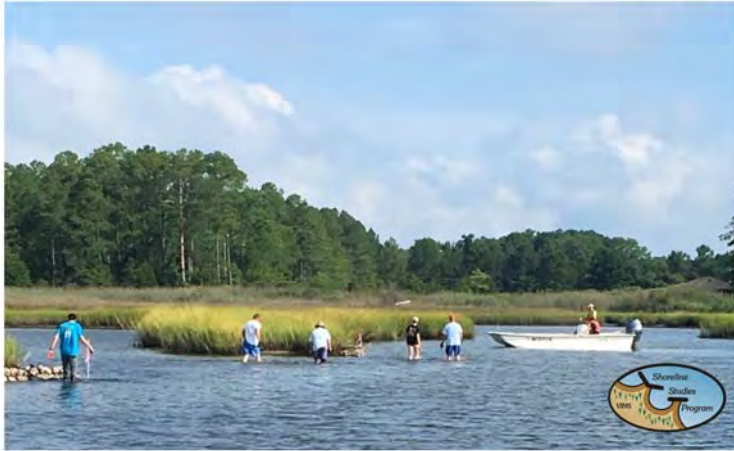
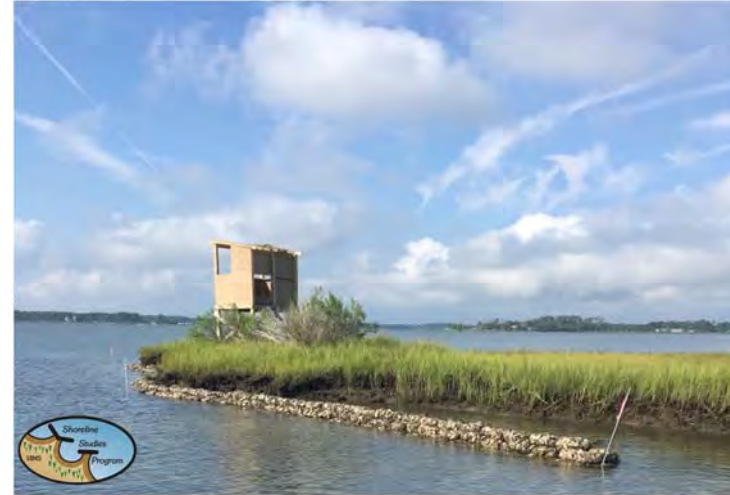
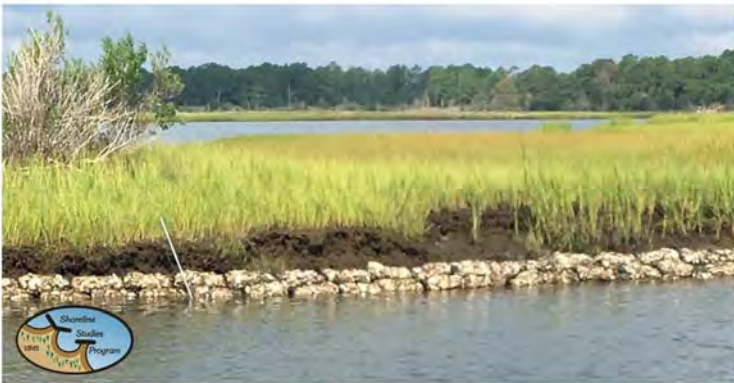
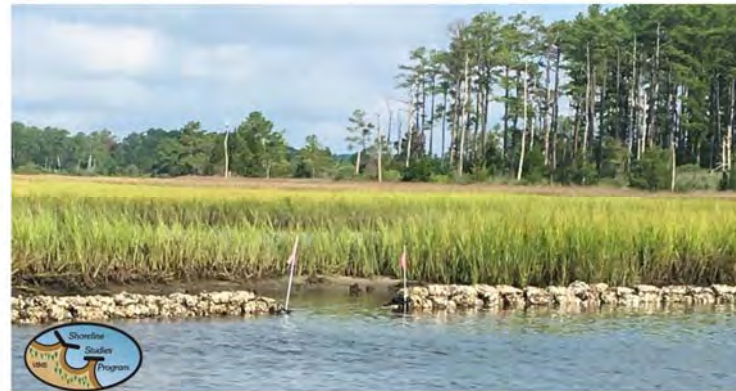
Final Sill

Photos of the 6 bag sills along the shoreline. Photo dates: Aug 15-16, 2017
