Shoreline Management In Chesapeake Bay

C. S. Hardaway, Jr. and R. J. Byrne

Special Report in Applied Marine Science and Ocean Engineering Number 356

October 1999

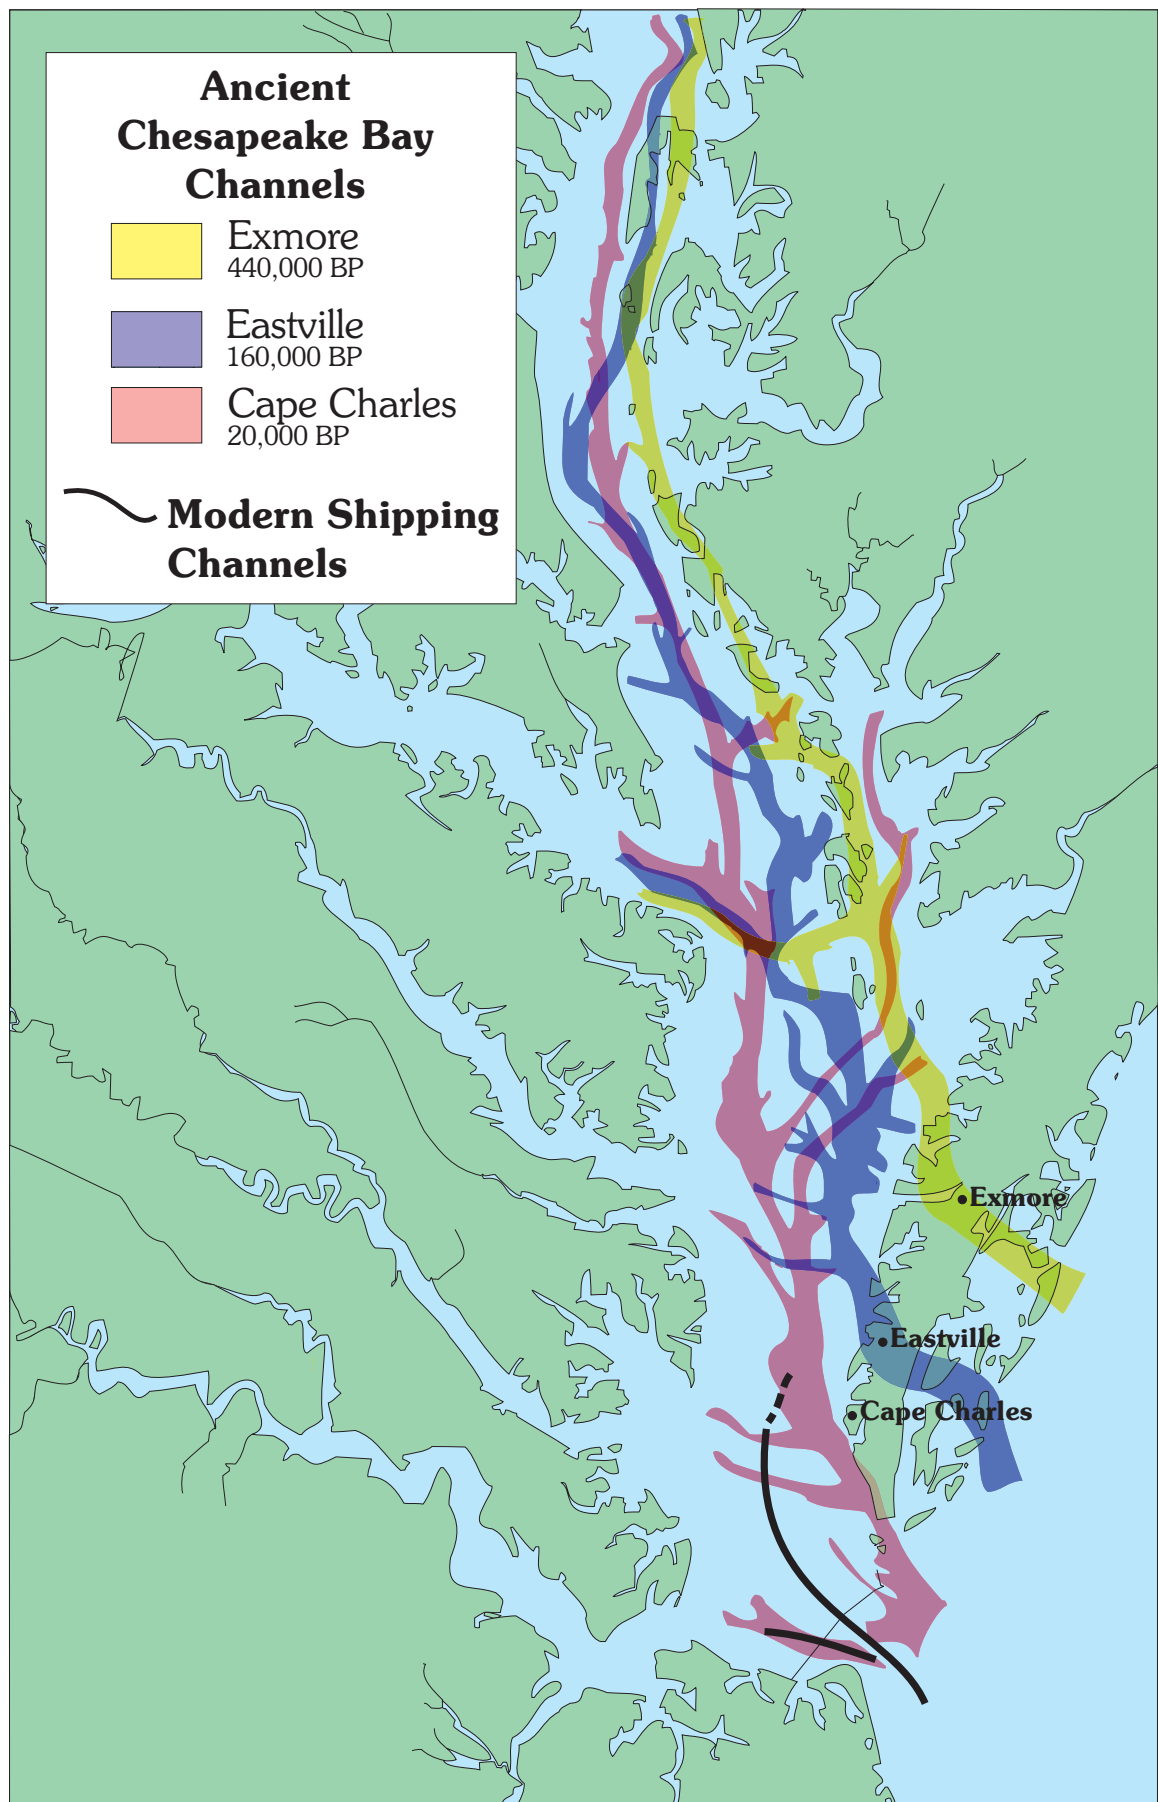
Figure 1
Map of the Chesapeake Bay today showing shifts in the Susquehanna River drainage. The Cape Charles channel formed about 20,000 years BP (before present); the Eastville channel formed about 160,000 BP; and the Exmore channel formed about 440,000 BP.

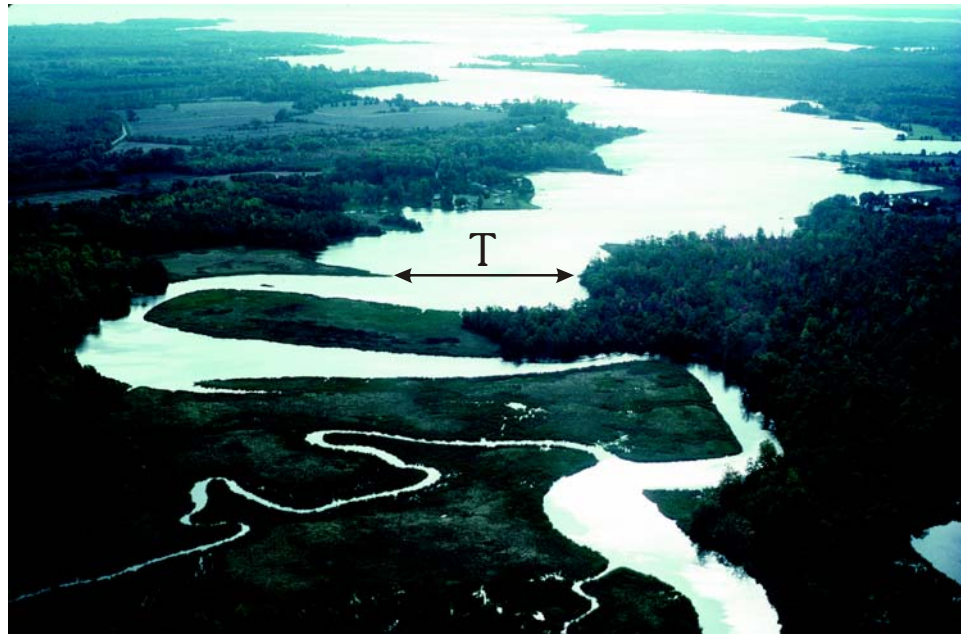
Figure 2
Broad marshes in foreground give way to fringing marshes downstream where there is greater fetch exposure. At the transition point (T), shoreline processes go from tidally dominated to wave dominated (Ware River, Va).

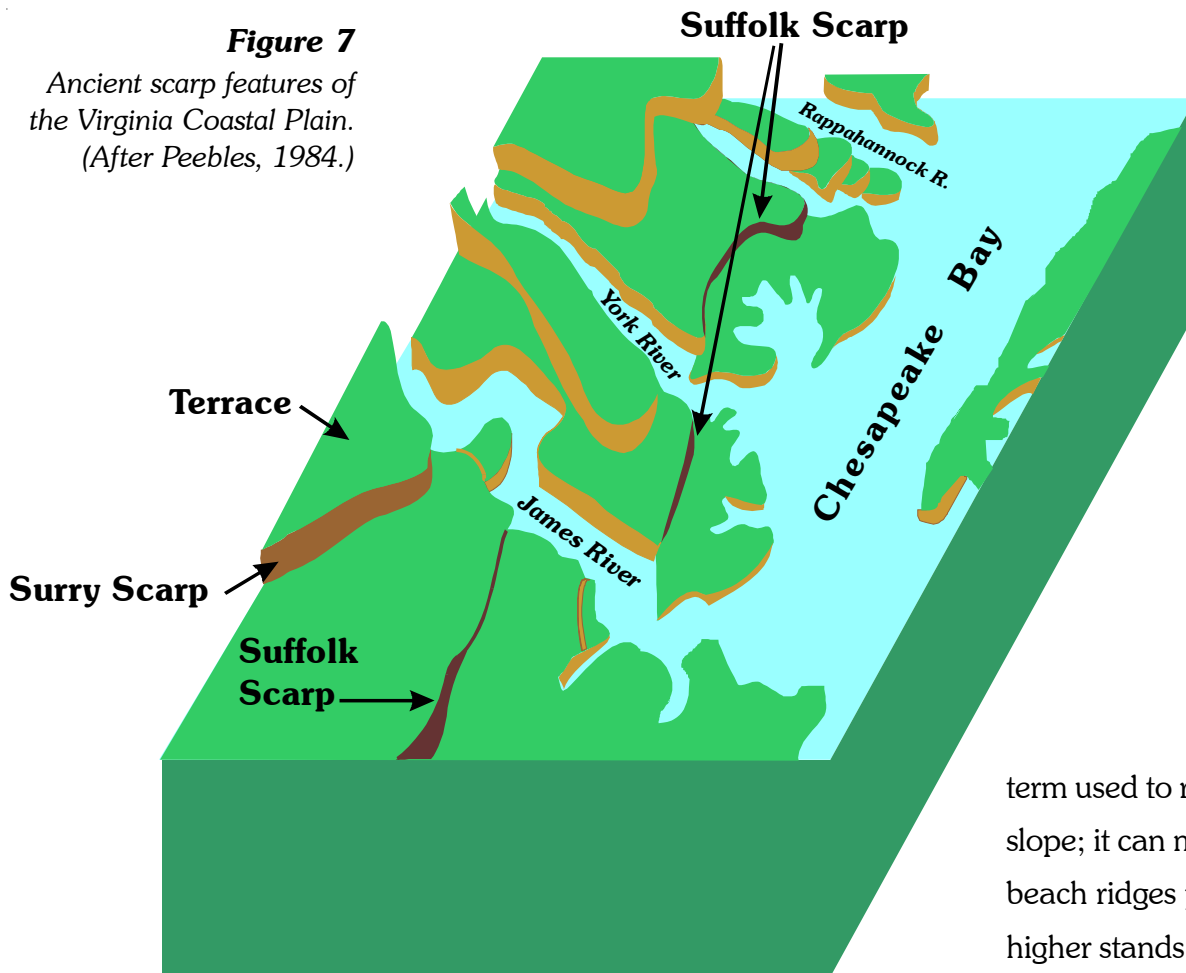
Figure 7
Ancient scarp features of
the Virginia Coastal Plain.
(After Peebles, 1984.)

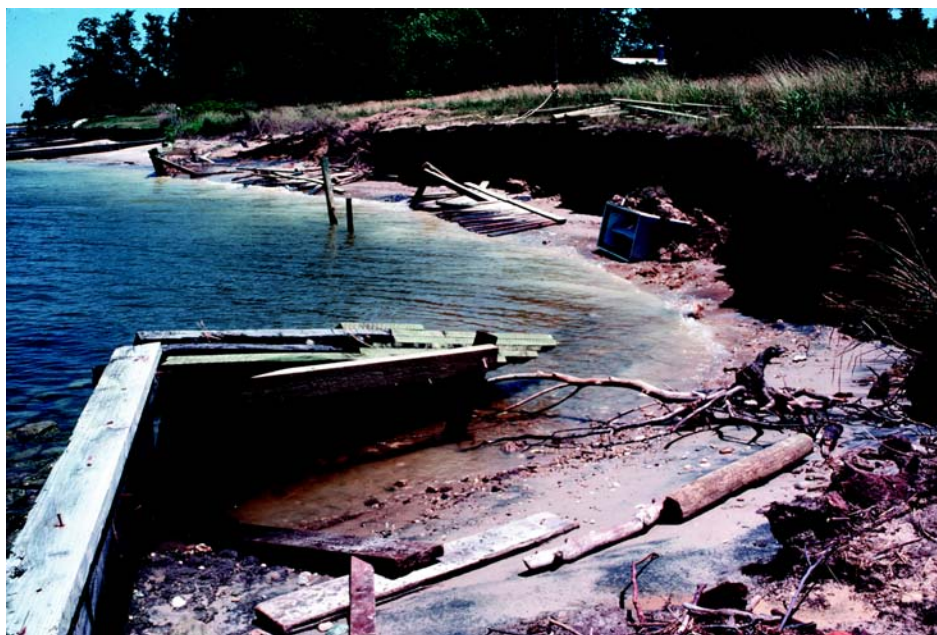
Figure 14B
Results of "short sheeting" and flanking resulting in loss of backfill in bulkhead construction. This particular structure was less than 2 months old.

Figure 14B depicts the results of “short sheeting” on the Potomac River where sheet piles were too short for site conditions.

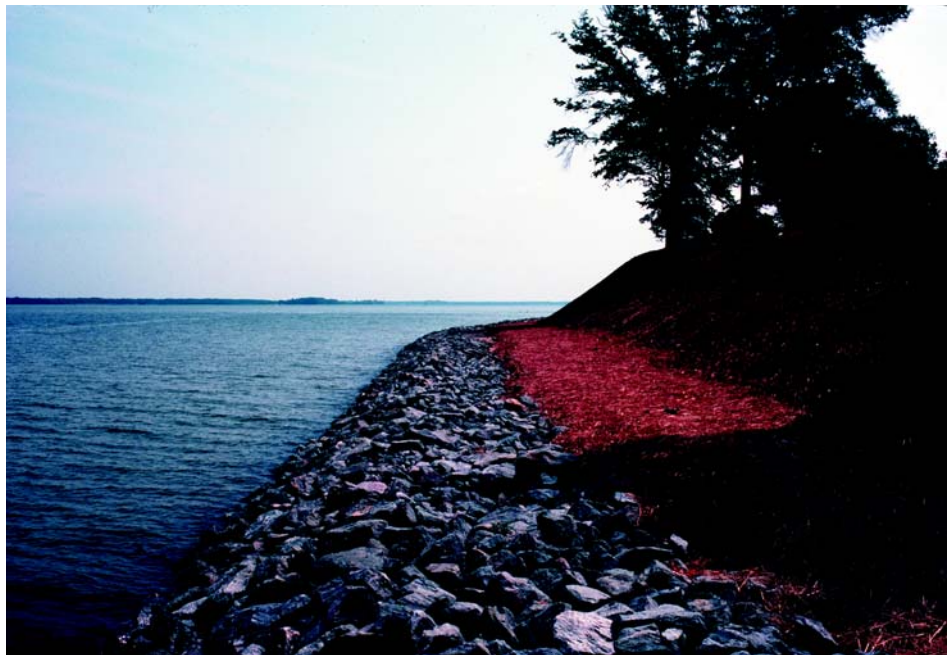
Figure 16A

Stone revetment shortly after construction on the Potomac River, Va.

Figures 16A & 16B show an example and a typical design cross-section of a stone revetment placed along a high bank. Revetments need to be high enough to withstand waves that may break over the top of the structure in extreme conditions. Banks usually need to be graded in order to obtain a stable slope. Armor stone must be good quality and proper size in order to support the size structure needed for a given shoreline. Armor made of

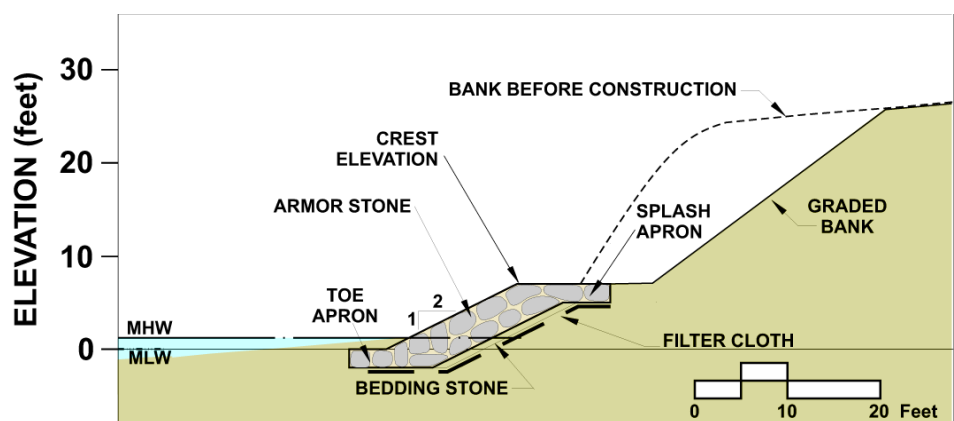
Figure 16B.

Cross-section of elements necessary for proper stone revetment design. There are usually two layers of armor stone over a bedding stone layer with filter cloth between the earth subgrade and bedding layer. Armor size is dependent on the design wave height which is determined from an analysis of wave climate for each project site.

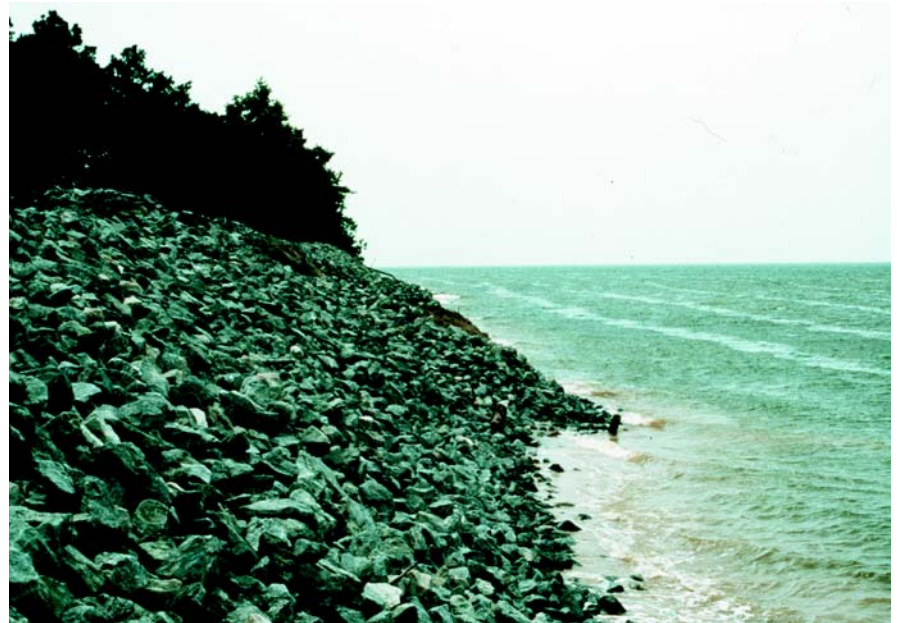
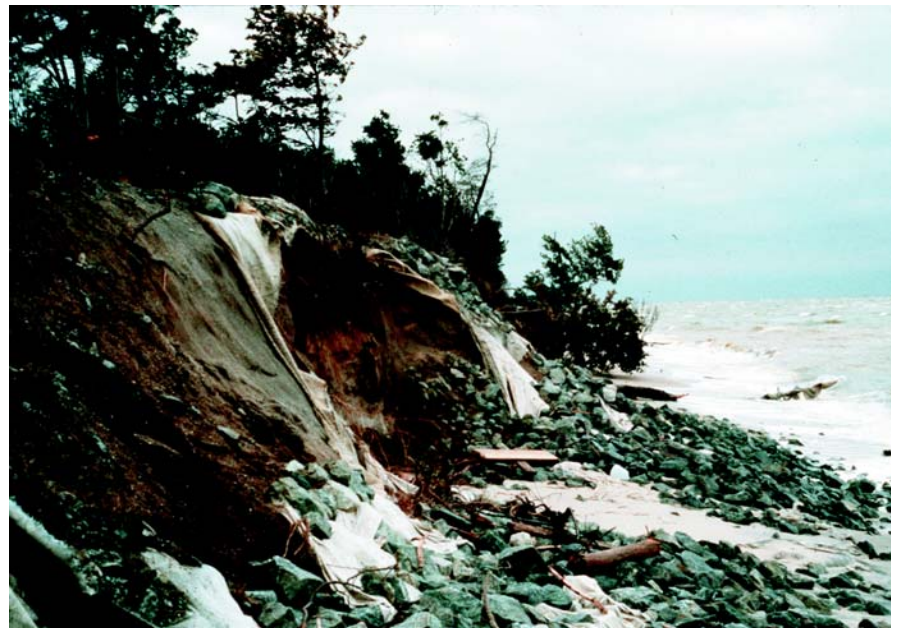
Failure of above structure after a modest storm event.

Problems can occur when the armor stone is undersized, placed in only one layer, or on too steep a slope. [Figures 17A and 17B](#) illustrate how such design flaws can result in total structural failure of a revetment.

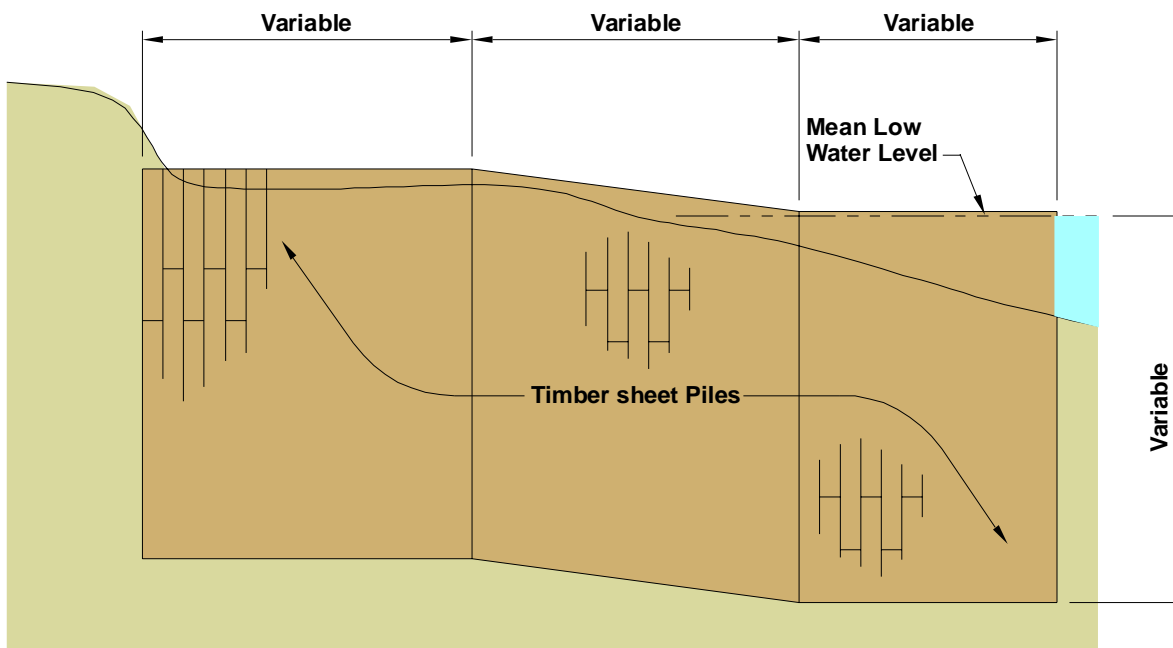
Figure 18
Wood bulkhead and groin: typical cross-sections and plan views (after USACE, 1984).

Between the 1950s and 1980s, groins were a popular way to trap sand and build a modest beach area. Traditionally these structures are constructed of wood (Figure 18). When used with or without a bulkhead or

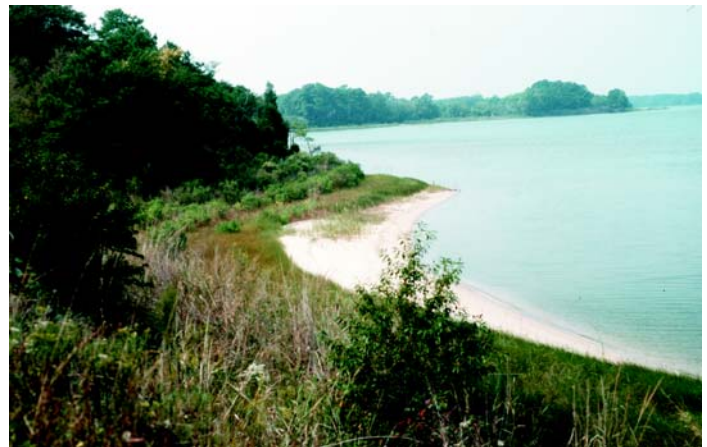
Figure 25C (lower)
Occahannock Creek marsh planting after 10 years of growth.

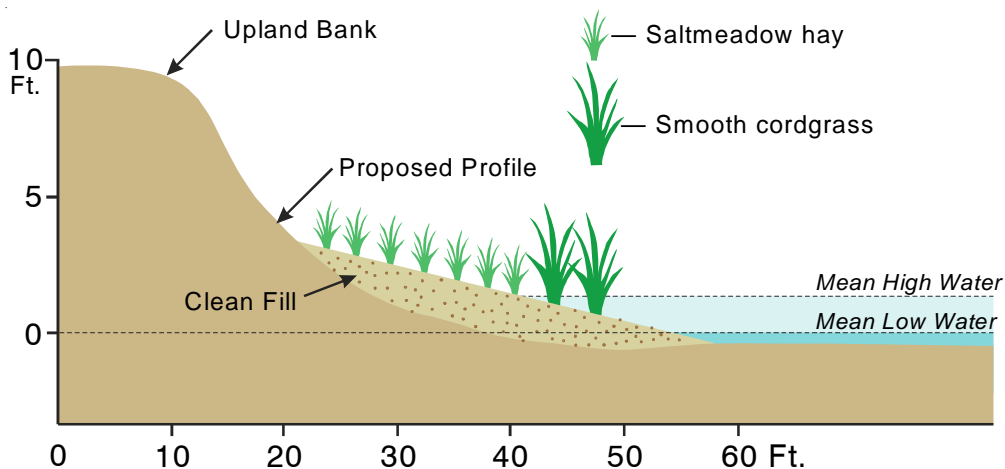
Figure 25D
This cross section shows a proposal plan to stabilize a typical eroding shoreline using clean sand to create the appropriate planting area.
